Tohoku Chapter, Architectural Institute of Japan Reconnaissance Report (05)  
of Miyagi Prefectural Agriculture High School, Natori City  
The 2011 off the Pacific Coast of Tohoku Earthquake  
Released on March 24, 2011

Dr. Daiki Sato, Research Associate  
Dr. Haruyuki Kitamura, Professor  
Tokyo University of Science

Summary by Shunsuke Otani, University of Tokyo

(1) Miyagi Agricultural High School, Natori City (March 20)

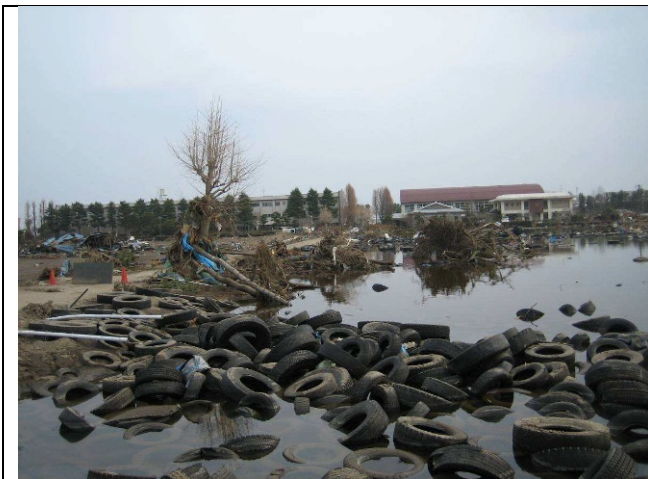
Photo 1: Campus after the tsunami attack

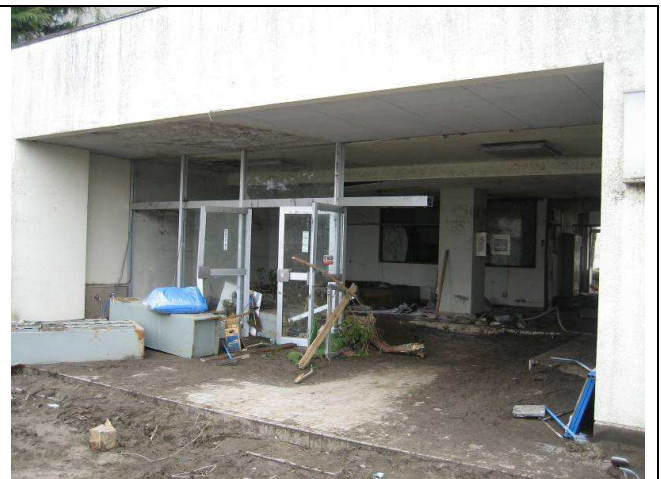
Photo 2: Entrance damaged by the tsunami

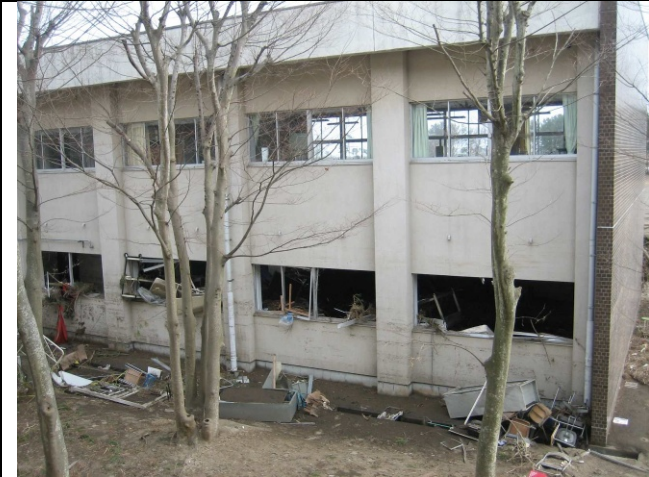
Photo 3: Broken windows in the 1-st story (north face of the South Building)

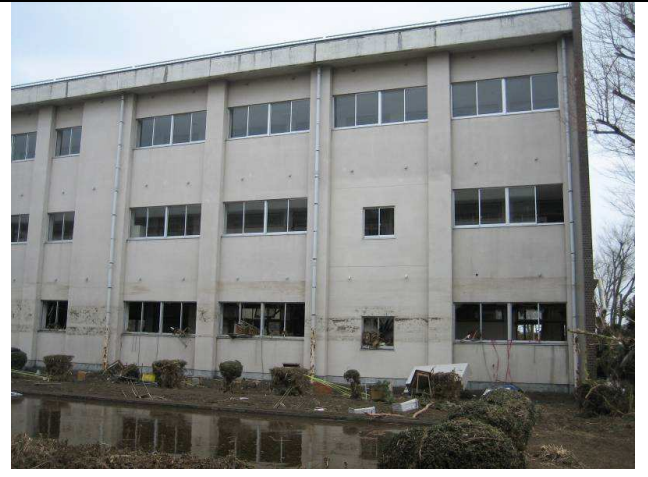
Photo 4: North face of the Central Building (the tsunami reached approx. 1 m above the first story windows)

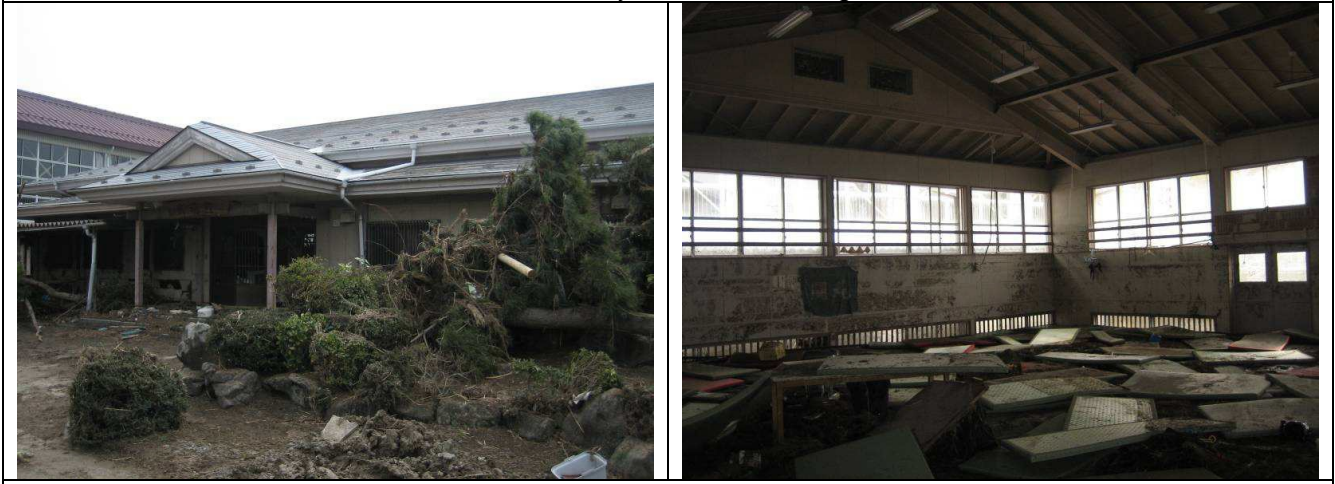
Photo 10: Gymnasium for military arts (No lighting fixture fell)

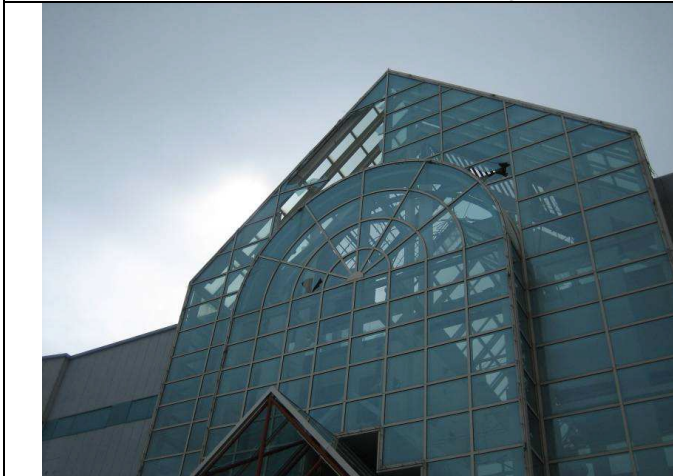
Photo 3: Drop of exterior glasses

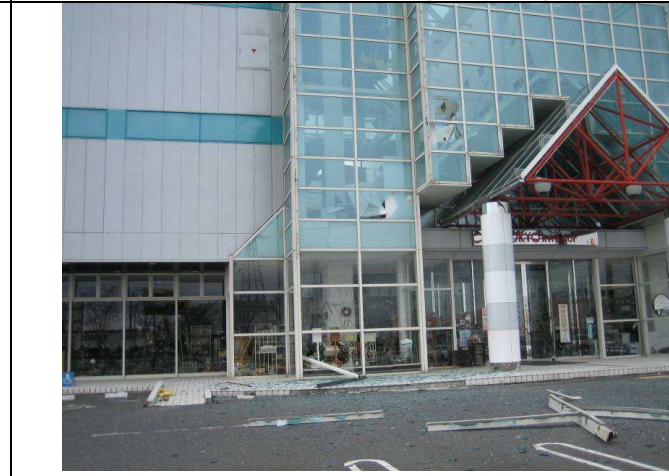
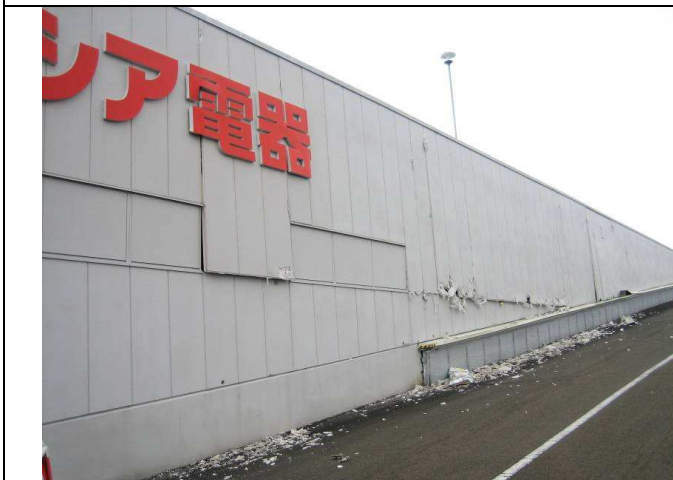
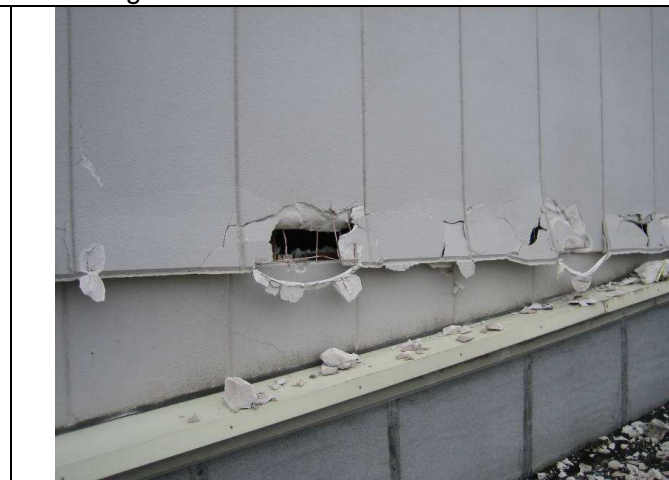
Photo 4: Breakage of ALC (autoclaved light-weight concrete) panel (Building 2)

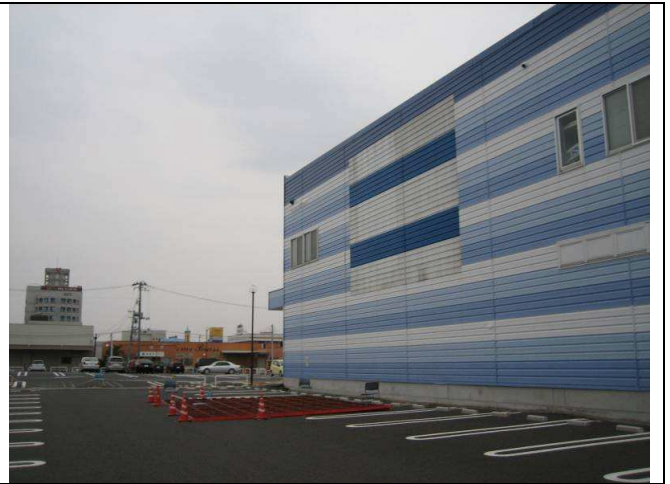
Photo 12: Fall of exterior panel to parking lot

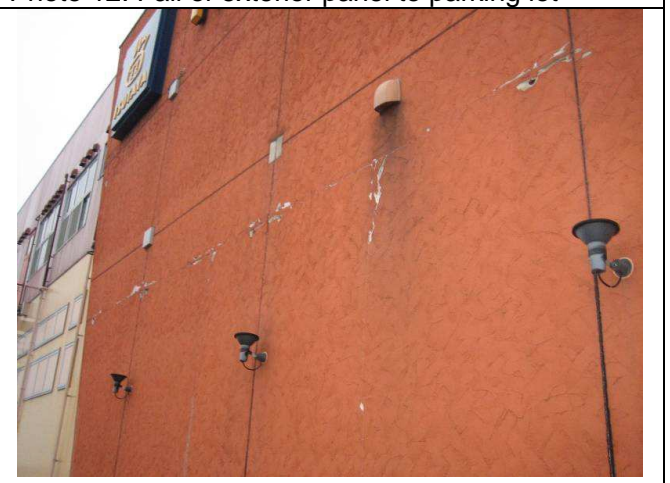
Photo 12: Cracking in ALC exterior panels

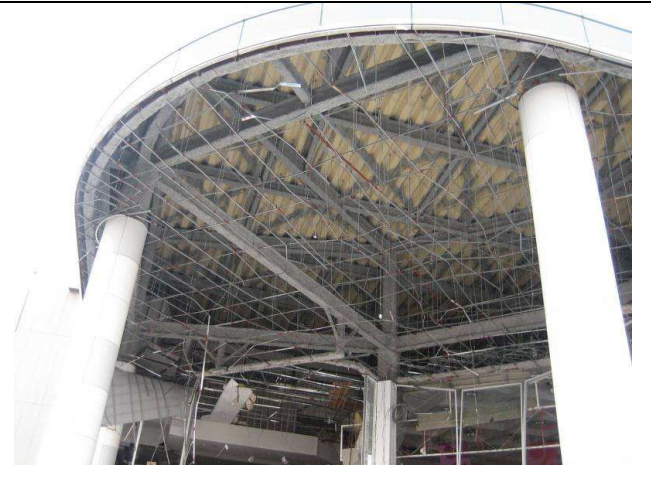
Photo 2: The ceiling dropped and roof skeleton is exposed

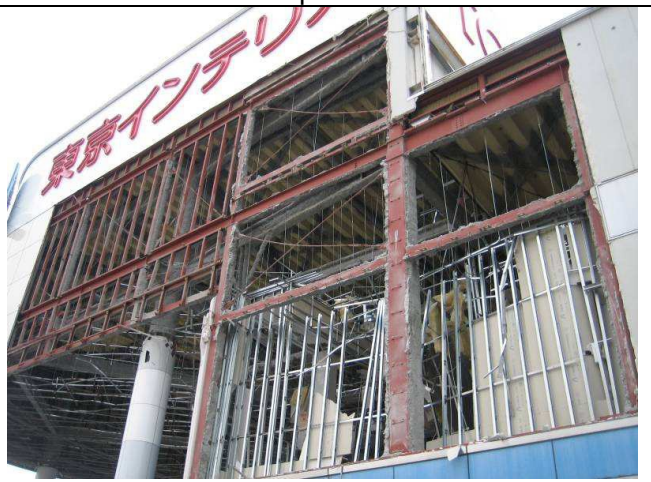
Photo 4: Fall of exterior curtain walls

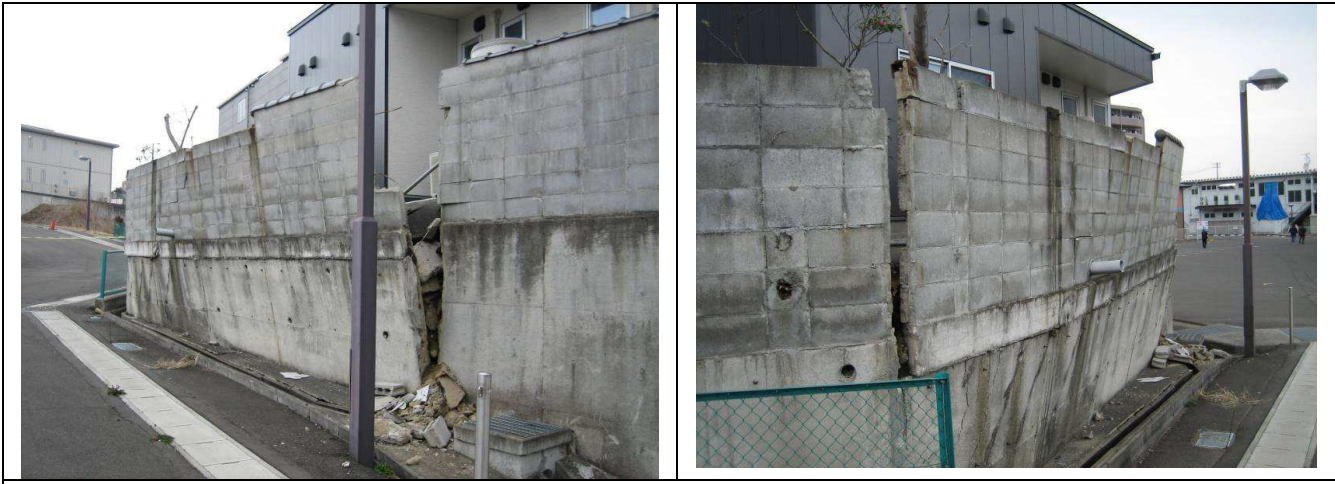
Photo 5: Fall of concrete block walls in the neighborhood
