Tohoku Chapter, Architectural Institute of Japan
Reconnaissance Report (16) on Mangoku-ura and Onagawa-cho
The 2011 off the Pacific Coast of Tohoku Earthquake
Released on April 15, 2011

Disaster Committee, Tohoku Chapter
Dr. Reiji Tanaka, Professor
Mr. Ryota Yamaya, Guest Researcher,
Tohoku Institute of Technology
(Translated by Shunsuke Otani, University of Tokyo)

This report describes the earthquake damage in Mangoku-ura (bay) and Onagawa-cho (town) of Miyagi Prefecture. The route maps of survey are shown in Map A for Mangoku-ura and Map B for Onagawa-cho.

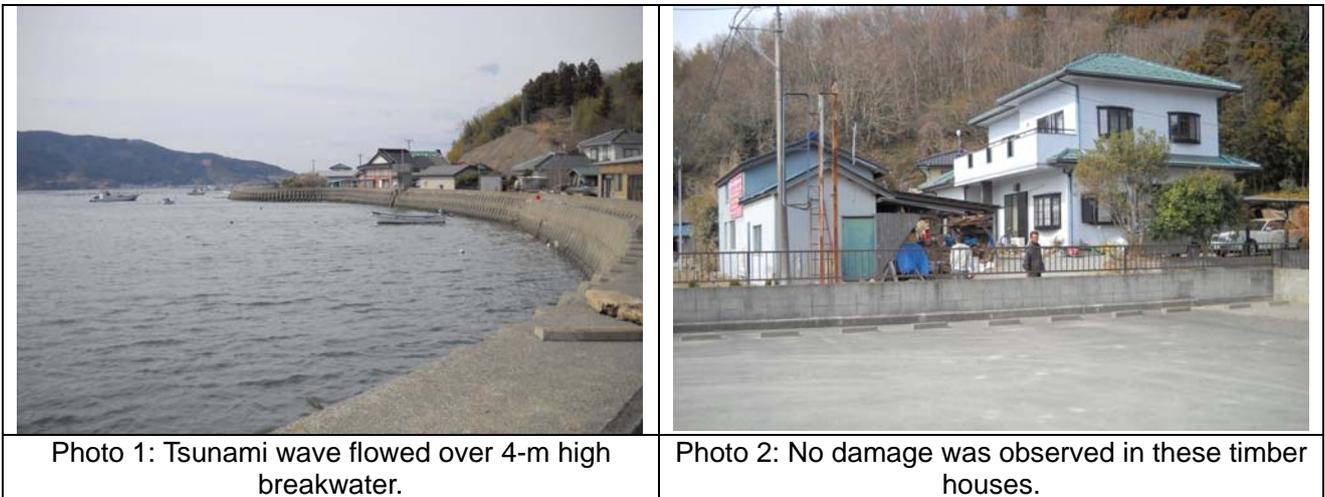
Mangoku-ura is located approximately 6 km to the east of Ishinomaki City, facing a small bay (Photo 1), and east of Onagawa-cho. Tsunami attacked the area, and the third tsunami wave was the highest flowing over a 4-m high breakwater. The damage was very small in this area (Photo 2).

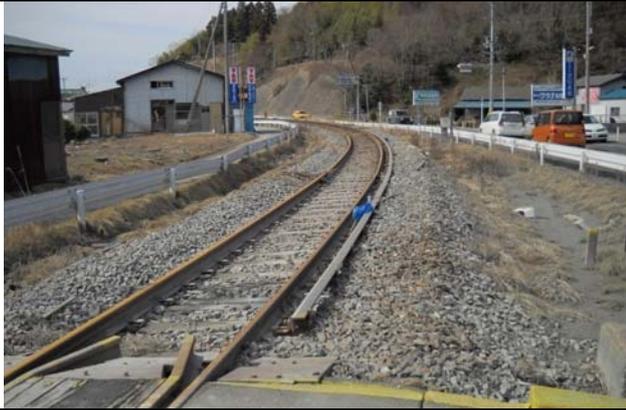
Photo 3: View to west from the Sanriku Railway

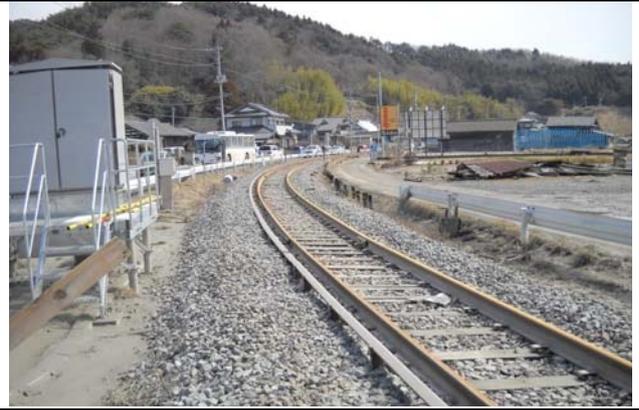
Photo 4: View to east from the Sanriku Railway.

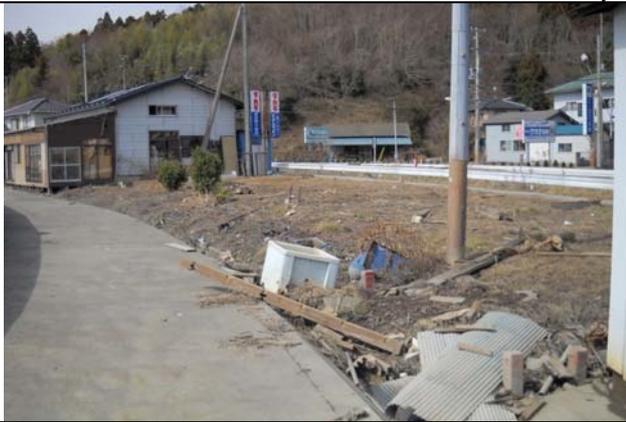
Photo 5: Some washed away items by tsunami near the railway.

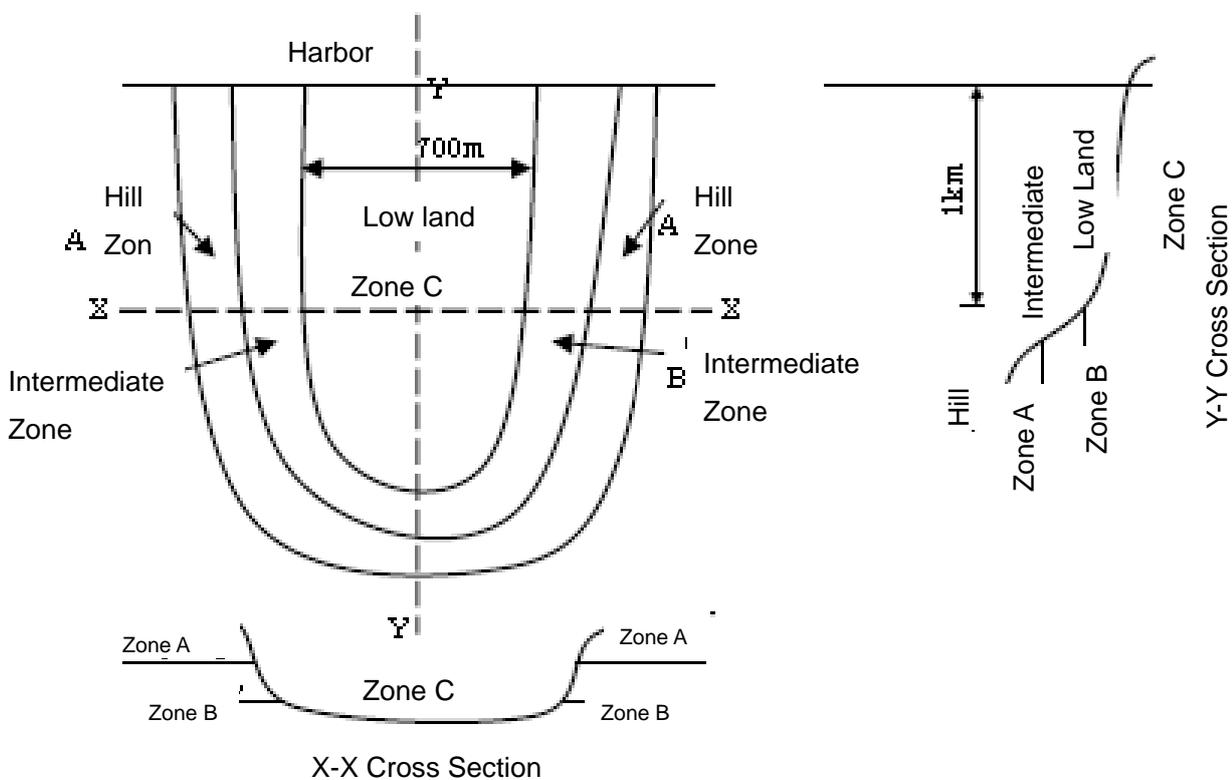
Fig. 1: Plan view and cross sections of Onagawa-cho (Zones A, B and C)

The town is surrounded by hills on three sides and open to the sea only on side (Fig. 1). The X-X cross section forms a U-shape valley; high altitude Zone A and intermediate altitude Zone B surround the low land Zone C in a horseshoe shape. The altitude of Zone C also increases with distance from the shore (see Y-Y cross section).

Zone C (low land): Timber houses were totally destroyed, but those at 1 km from the shore did not suffer damage. Reinforced concrete (RC) and steel buildings were standing.

Zone B (intermediate high land): Lightly damaged and no damaged houses survived tsunami.

Zone C (high land): Most timber houses suffered no damage.

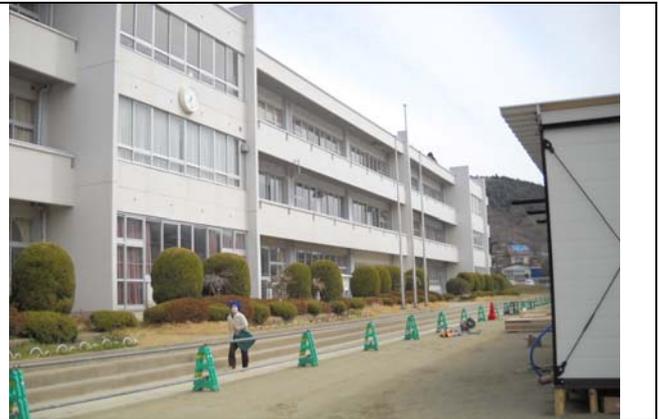
Photo 2: No damage in the school building.

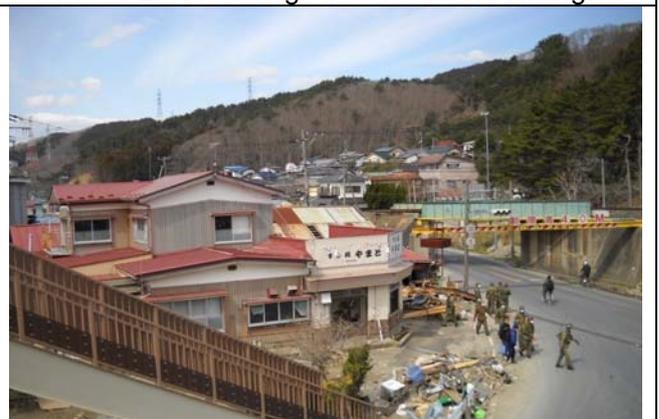
Photo 4: Tsunami wave reached the road beneath the school..

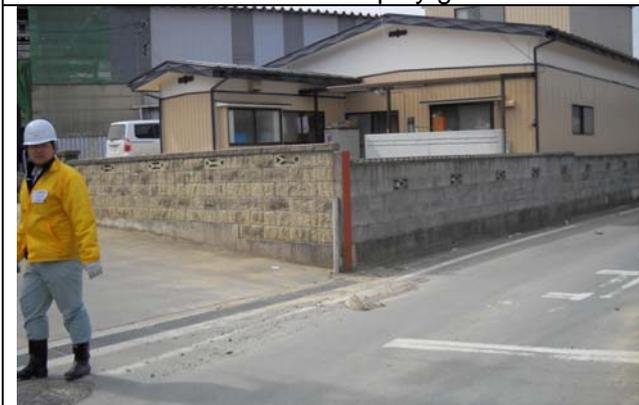
Photo 5: Houses protected by concrete walls suffered no damage.

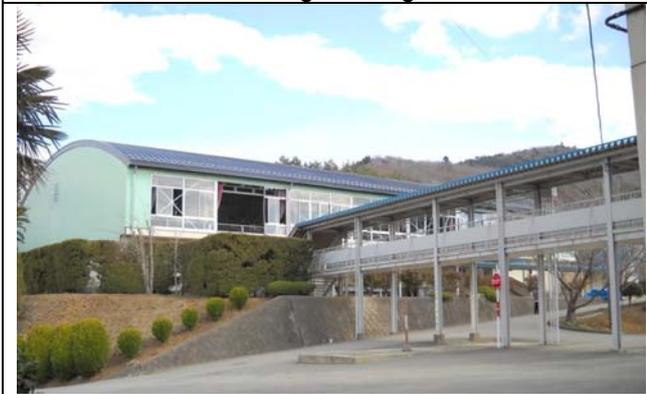
Photo 8: Window glasses were broken in the gymnasium (1).

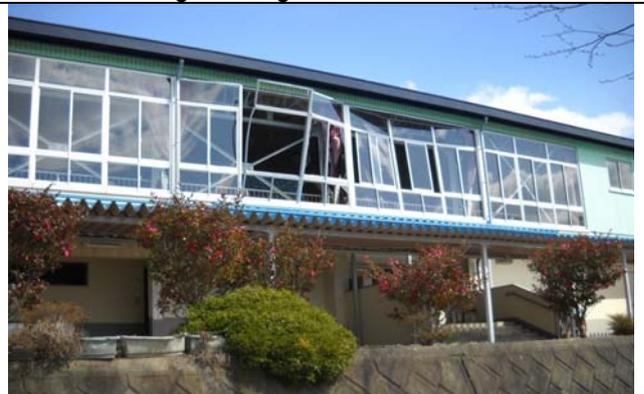
Photo 9: Window glasses were broken in the gymnasium (2).

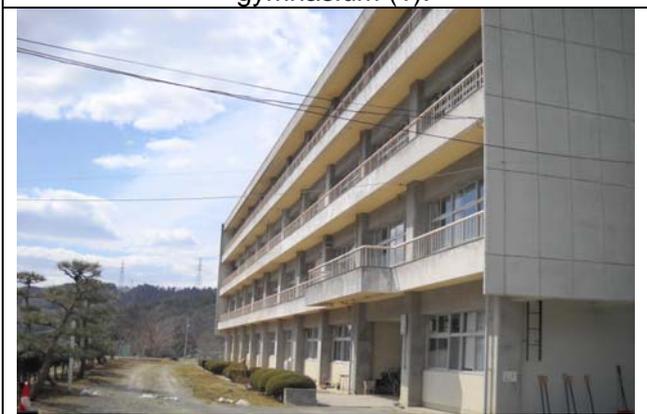
Photo 10: The school building suffered no damage.

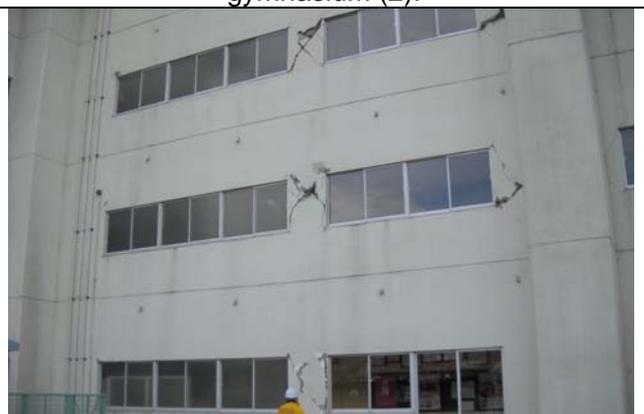
B). Photo 8 shows the gymnasium. Window glasses were broken (Photo 9). Photo 10 shows the school building, and no damage was observed. Photo 11 shows north view; shear cracks were seen on a mullion wall. In only one column with a wing wall suffered a shear crack.

Photo 11: Shear cracks in mullion walls in the north.

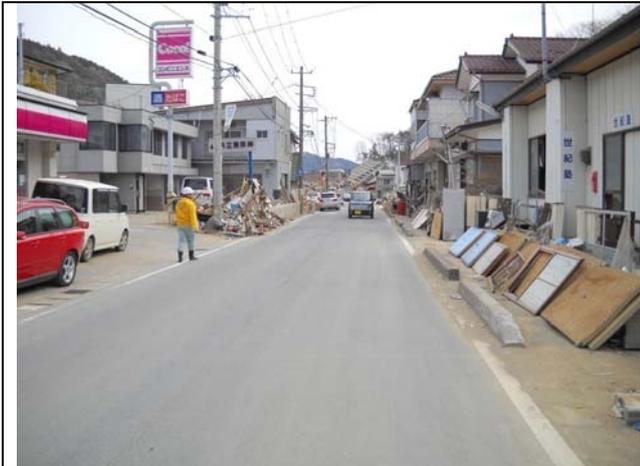
Photo 12: Damage increased with descending height (1)

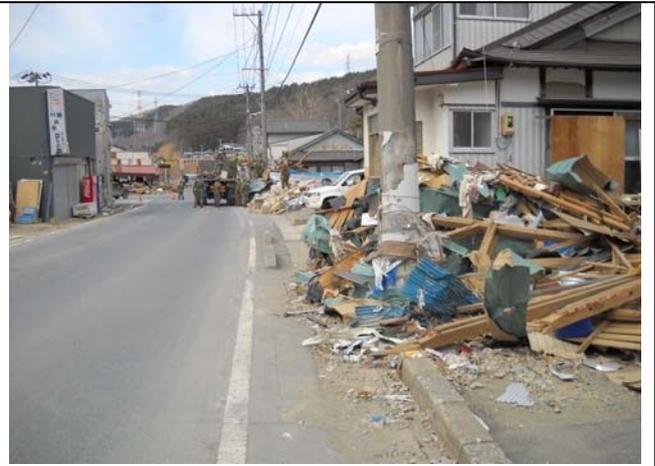
Photo 13: Damage increased with descending height (2)

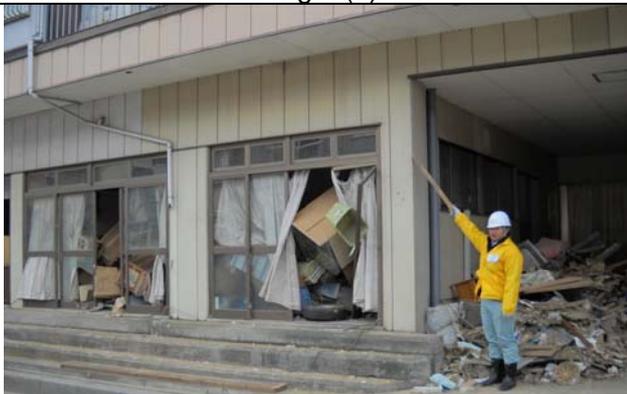
Photo 14: Damage became significant as the tsunami height reached approx. 1.8 m.

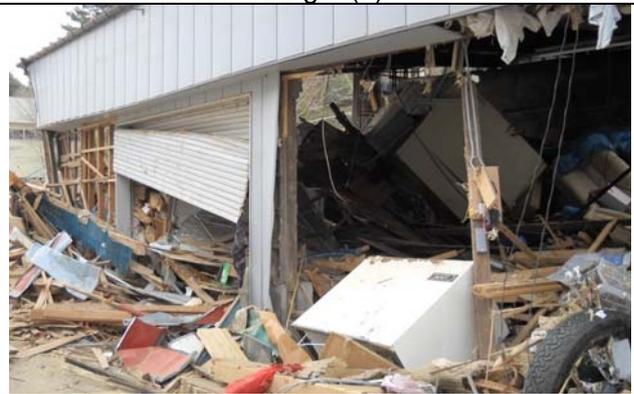
Photo 15: In the area where tsunami wave reached 1.8 m high, the first story was wrecked.

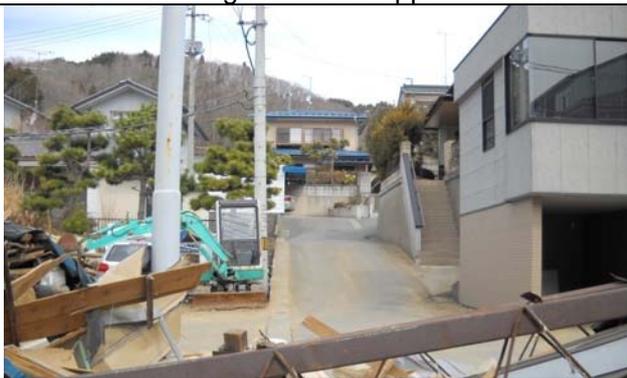
Photo 16: Not much damage in houses on the hill side in Zone B.

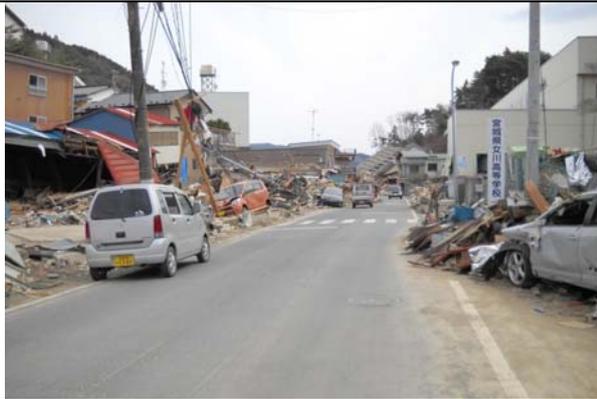
Photo 17: Some houses were standing and others collapsed in Zone B.

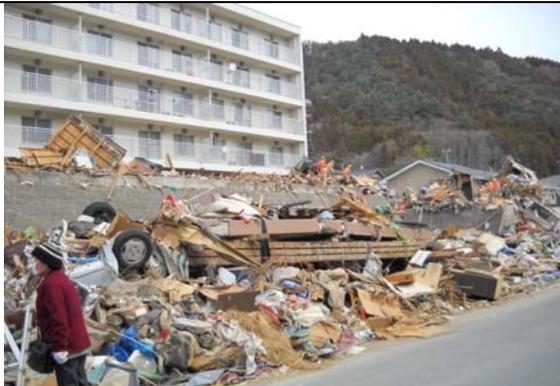
Photo 18: Most timber houses were washed away in Zone C (1).

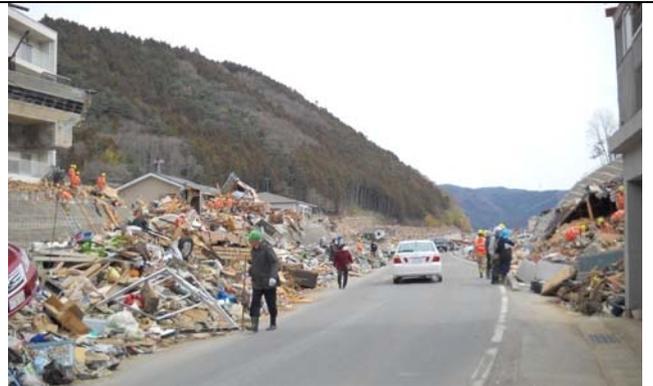
Photo 19: Most timber houses were washed away in Zone C (2).

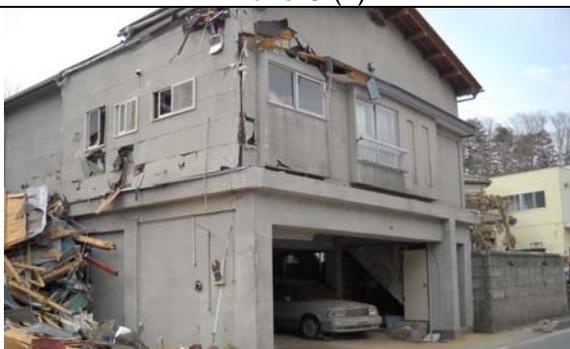
Photo 20: First story RC and second story timber house in Zone C.

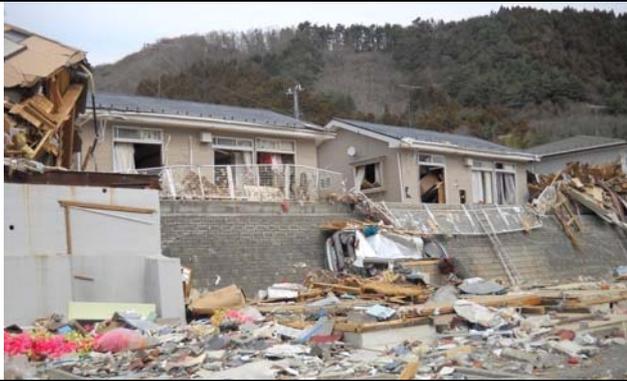
Photo 21: Total destruction of houses in low land (1).

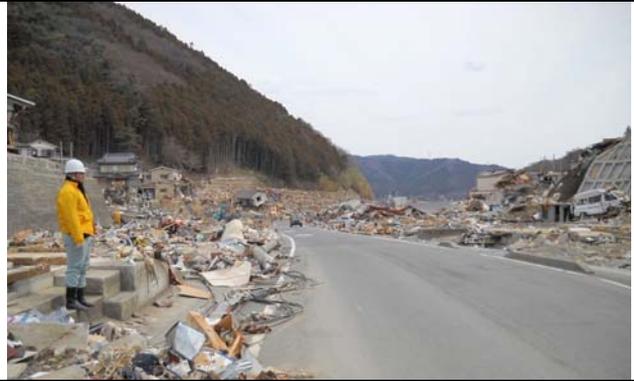
Photo 22: Total destruction of houses in low land (2).

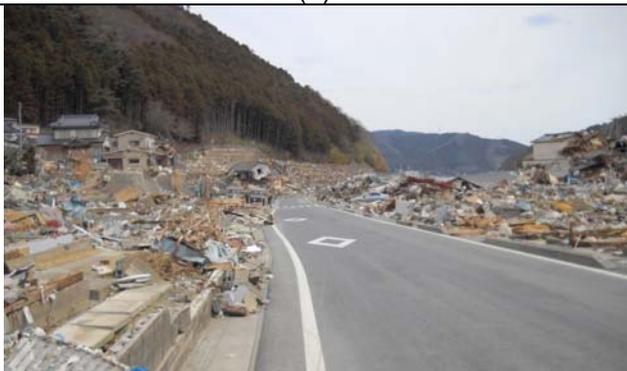
Photo 23: Total destruction of houses in low land (3).

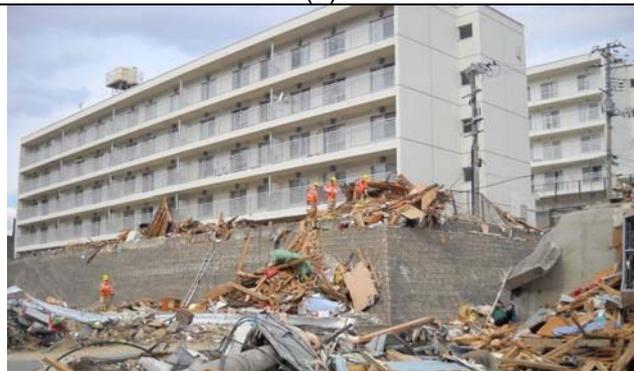
Photo 24: Undamaged reinforced concrete condominium buildings on slightly higher altitude

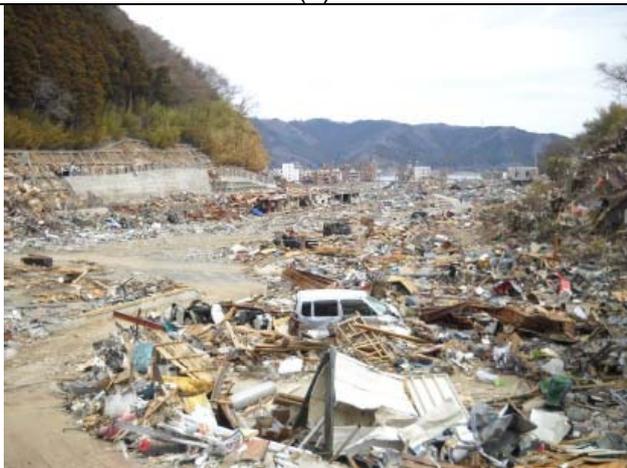
Photo 25: Totally destroyed houses in Zone C (1)

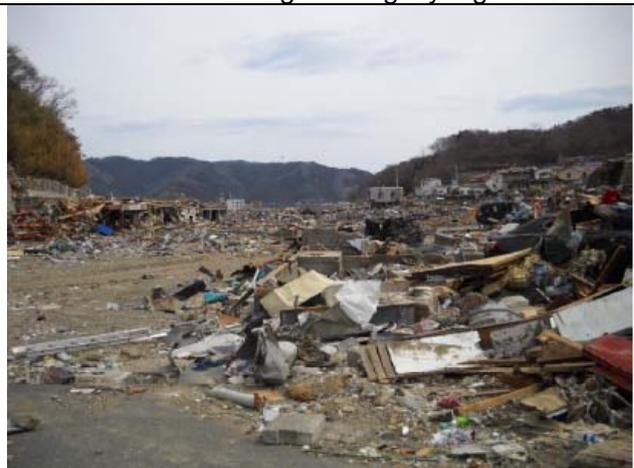
Photo 26: Totally destroyed houses in Zone C (2)

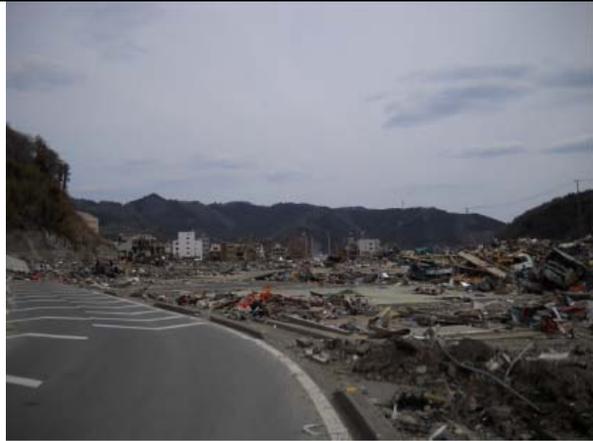
Photo 27: Totally destroyed houses in Zone C (3)

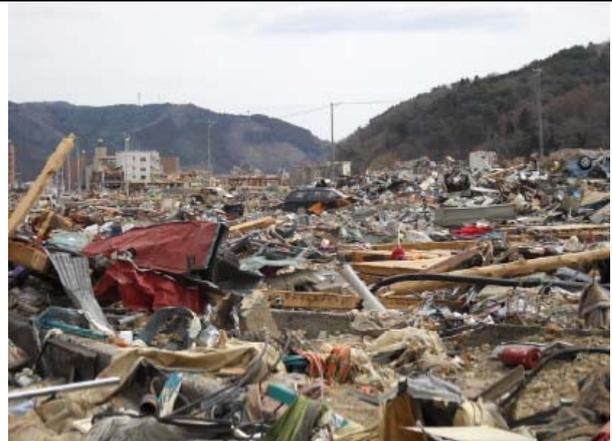
Photo 28: Totally destroyed houses in Zone C (4)

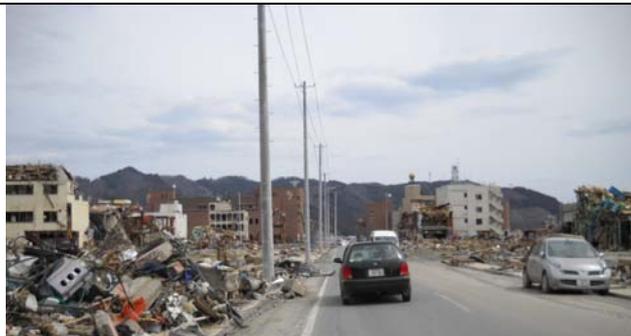
Photo 29: Reinforced concrete and steel structures remained standing near the port.

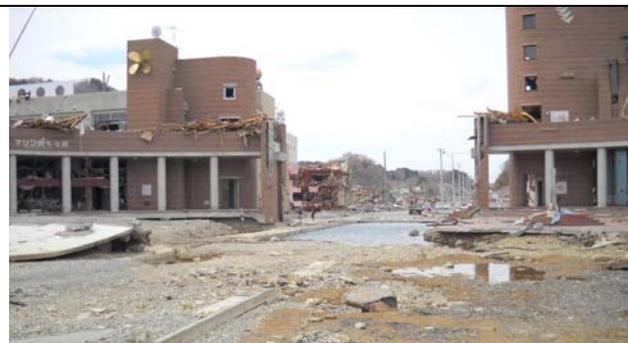
Photo 31: The corridor between the two buildings was washed away.

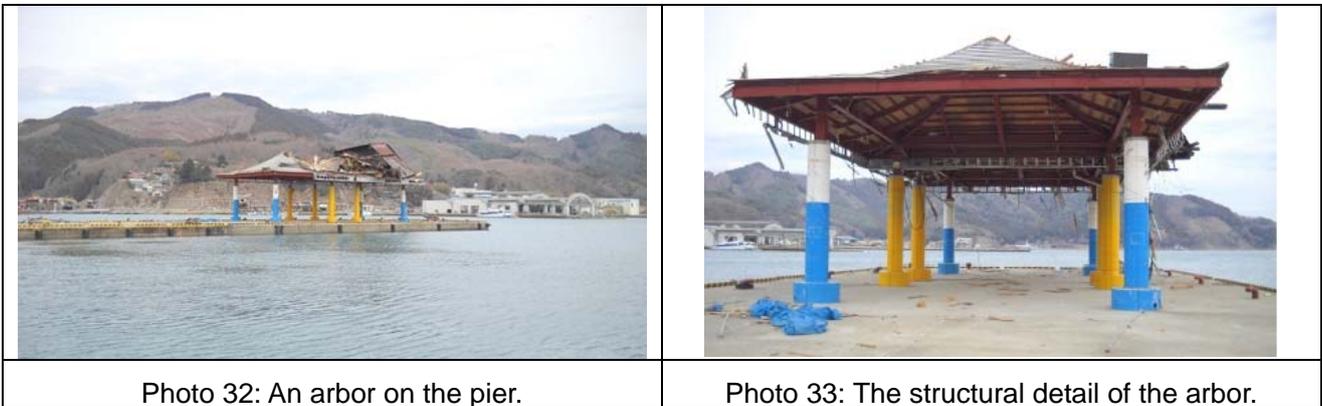
Photo 32 shows a pier sticking out to the shore. A simple steel arbor remained standing on the pier. Photo 33 shows the detail. Tsunami wave must have passed over the arbor, but no damage. This is an example that a structure with thin members can survive tsunami attack.

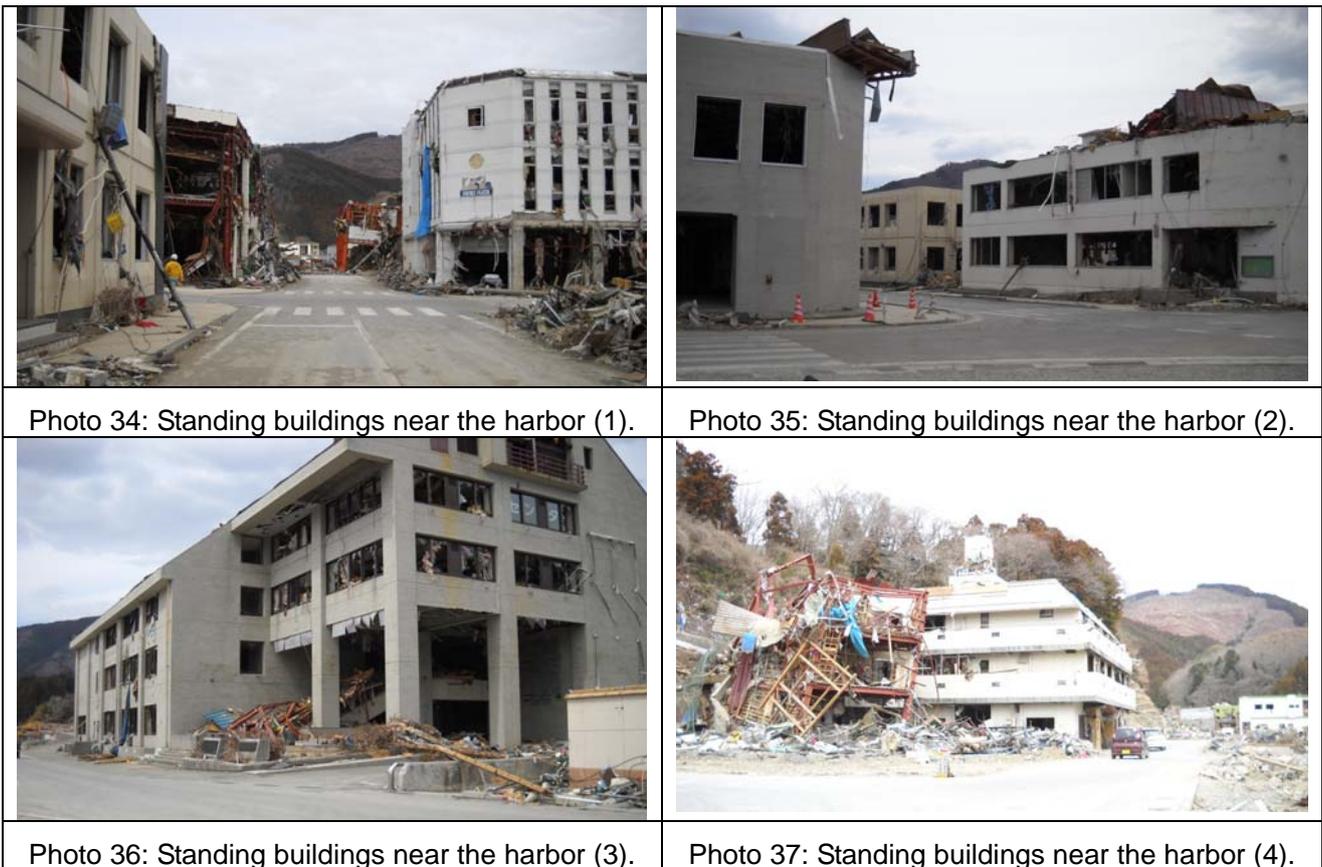
In the neighborhood of the Onagawa Harbor, there remained many reinforced concrete and steel buildings (Photos 34 to 37, No. 7 in Map B).

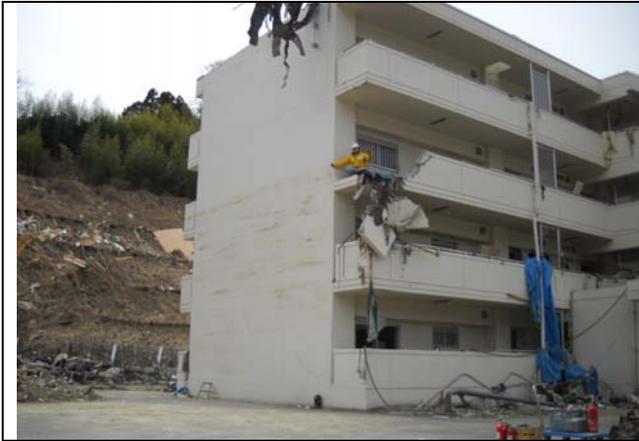
The tsunami wave reached the third floor of the building. The tsunami wave height was estimated to be approx. 8 m on this site. Some rubbish can be seen at the corner of roof; the tsunami height could be higher. Near this building, there was a railway line (Photos 39 and 40, No. 9 in Map B). The rail was completely destroyed.

Photo 38: A four-story RC condominium.

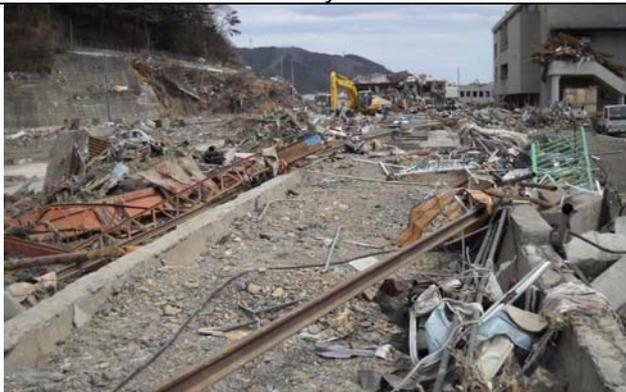
Photo 40: Rail was destroyed.

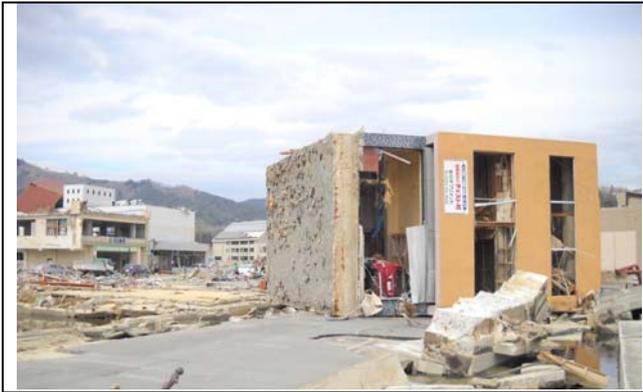
Some reinforced concrete buildings collapsed in this area (No. 7 and 8 in Map B). The collapse was not due to the failure of structural members, but entire buildings were overturned (Photos 41 to 43). The reasons for the collapse needs to be studied.

Photo 41: Overturned RC buildings (1).

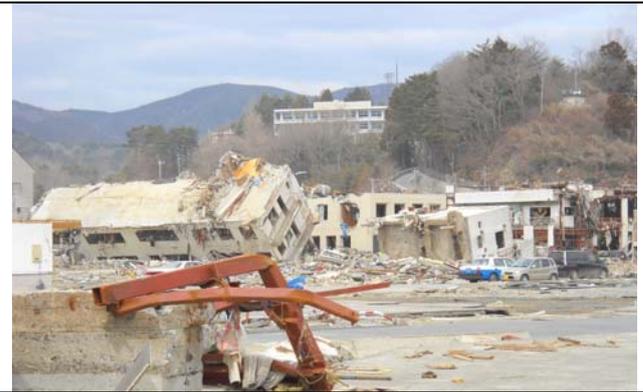
Photo 42: Overturned RC buildings (2).

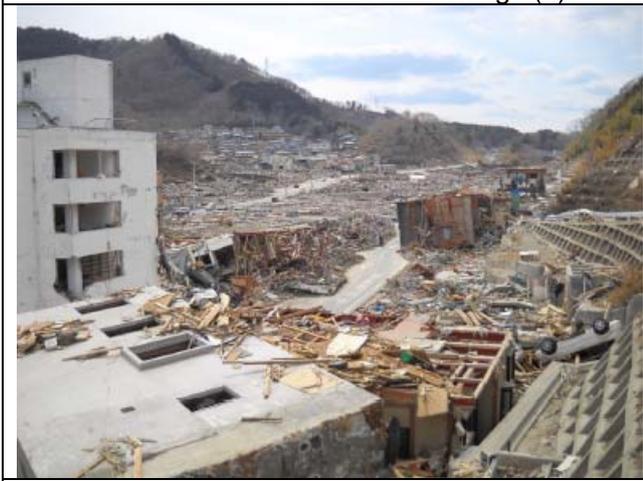
Photo 43: Overturned RC buildings (3).

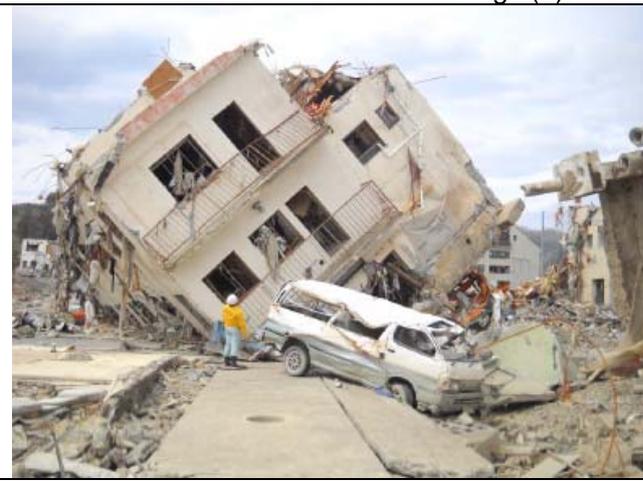
Photo 44: Overturned RC buildings (4).
