The 2011 Off the Pacific Coast of Tohoku Earthquake
- Quick Investigation Report on Earthquake Damage on Buildings -

Professor Masato Motosaka, Tohoku University
(Translation by Shunsuke Otani, University of Tokyo)

March 12, Saturday, Preliminary Investigation

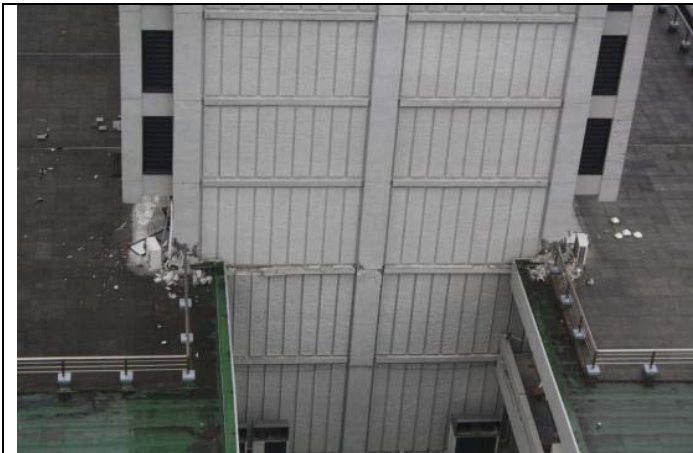
The damage of the east end walls is shown in Photos 1 and 2. The base of the third story columns in the east and west end walls suffered heavy damage due to high axial forces caused by the overturning moment. Non-full web steel element was exposed and buckled in a steel encased reinforced concrete column, and longitudinal reinforcement was either fractured or buckled (Photo 3). After the failure at column bases, the rocking vibration of the building must have occurred. Exposed longitudinal reinforcement at the base of damaged columns revealed new fracture by this earthquake and old fracture of rusted reinforcement by the previous earthquake.

Photo 1: Damage of end walls from roof of the adjacent building

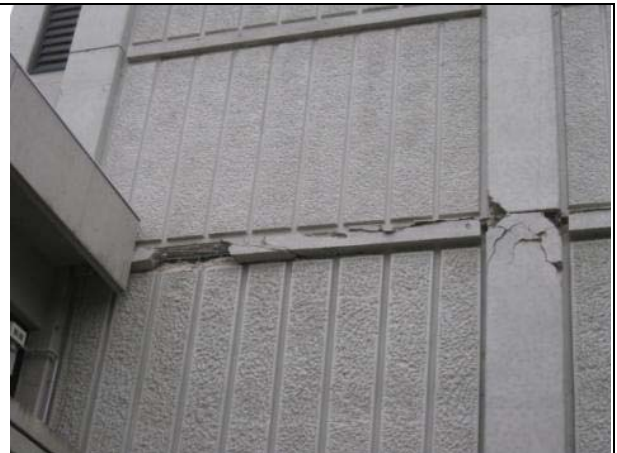
Photo 2: Damage of end walls from the ground

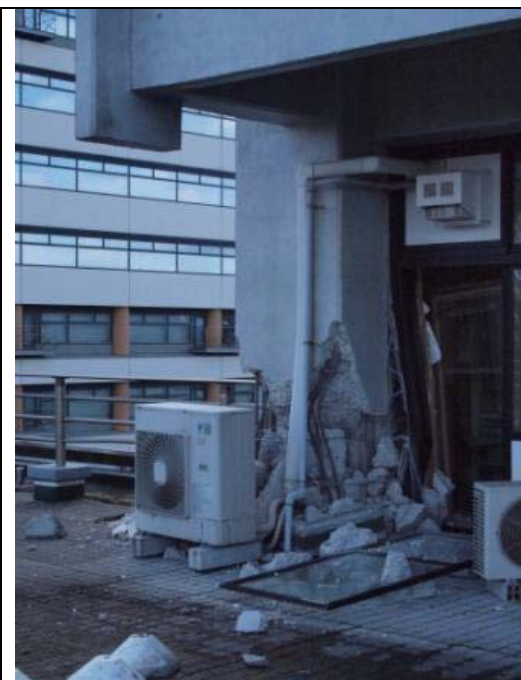
Photo 3: Damage of north-east corner column

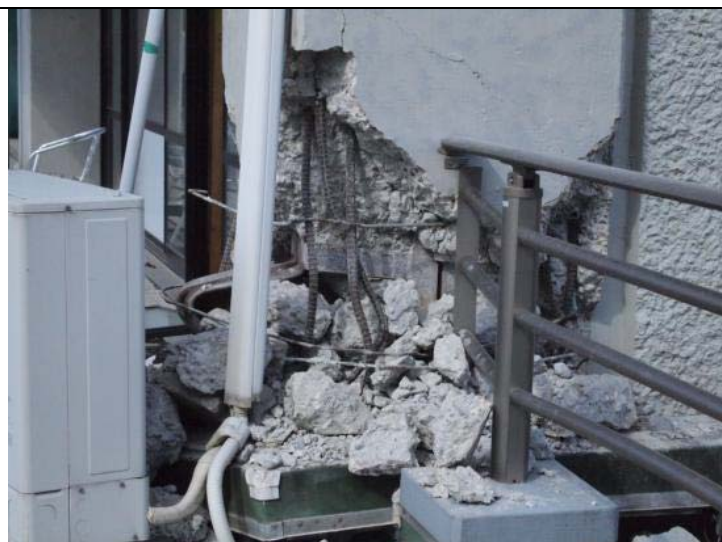
Photo 4: Damage of south-east corner column

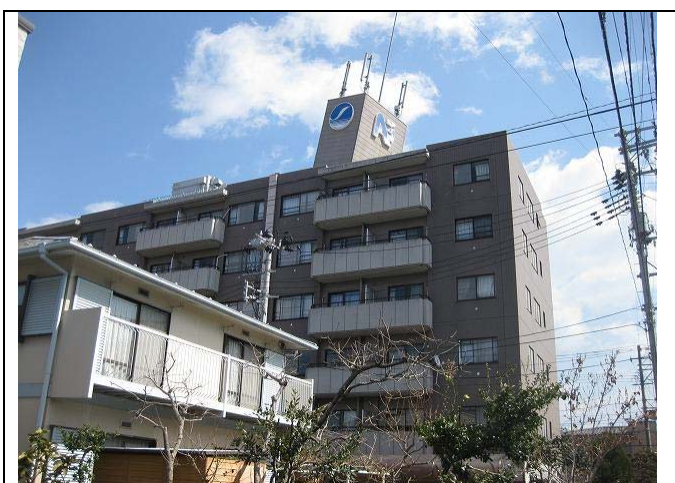
The information of building damage was obtained at the disaster headquarter of Wakabayashi Municipal Office. The penthouse of a six-story reinforced concrete building tilted in Narita-machi (Photo 5); the building did not show any other damage.

Photo 5: A tilted penthouse of a six-story reinforced concrete condominium building

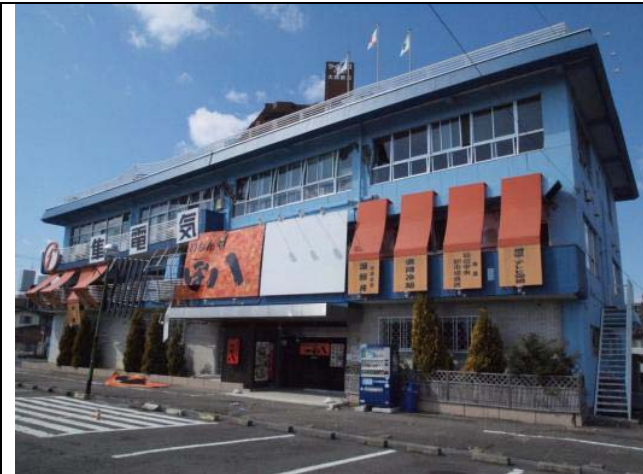
Three-story reinforced concrete building collapsed in the second story in Yamato-machi 5-chome (Photos

6 and 7), probably caused by torsional oscillation.

Photo 6: Collapse in the second story of a three-story reinforced concrete building in Yamato-machi 5-chome.

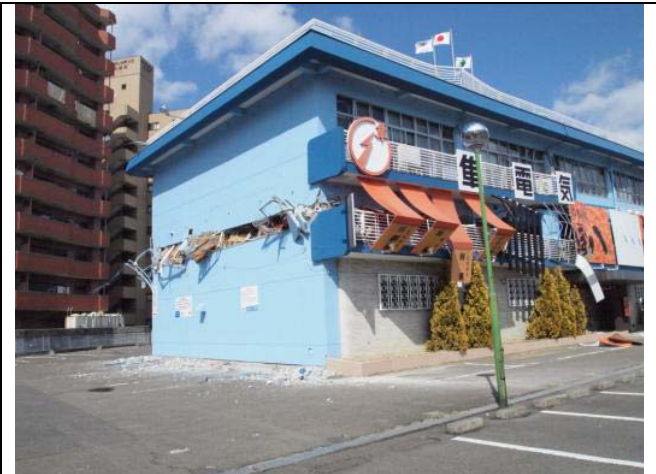
Photo 7: Collapse in the second story

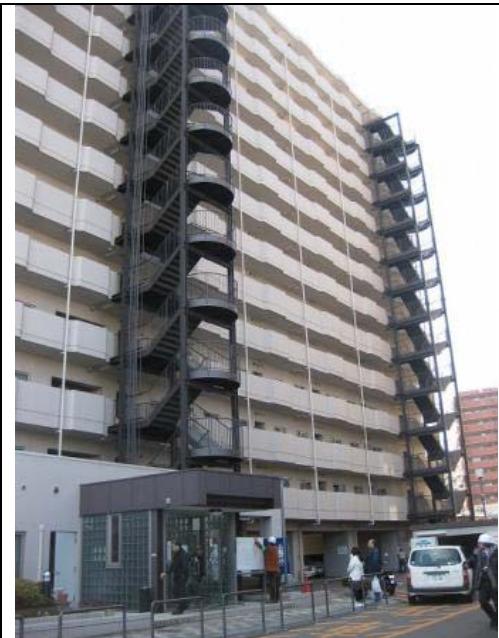
Photo 8 (a) A 14-story reinforced concrete building

X-shaped shear cracks were observed in non-structural walls facing the hall way from second to nine stories in a fourteen-story reinforced concrete condominium building sold in 1981, Yamato-machi 5-chome (Photo 8); no such damage was observed in the first story (pilotti: soft first-story) and 13 and 14th stories. Doors are not located in the non-structural walls and could be opened.

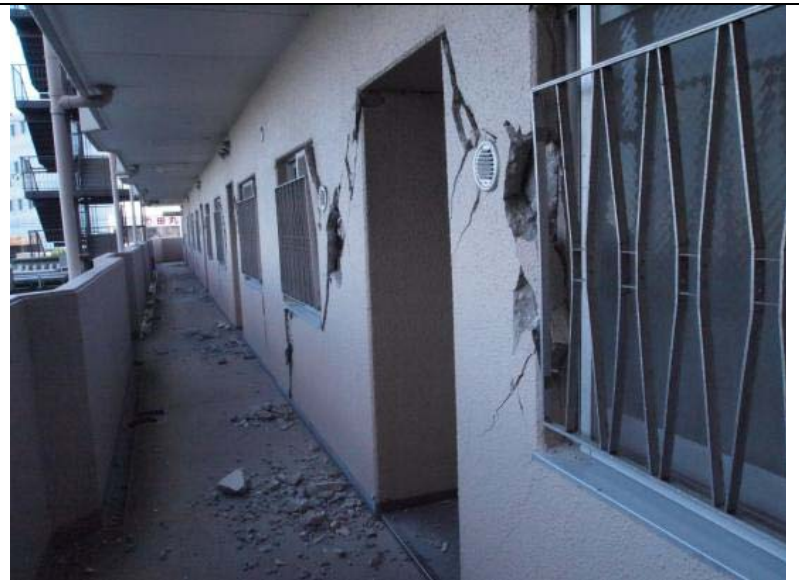
Photo 8 (b): Damage of non-structural walls in the hall way

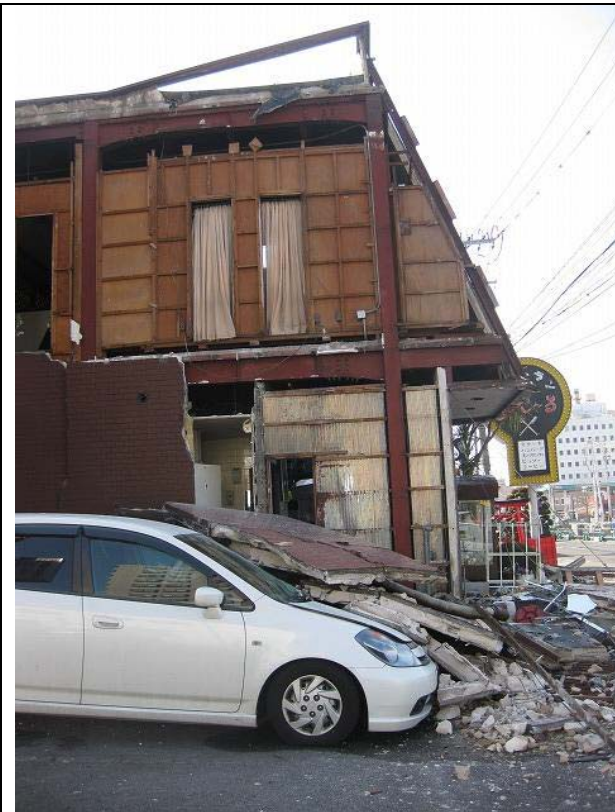
Along the Shinterakouji in Yamato-machi 5-chome, exterior wall finishing fell from a two-story steel construction (Photo 9) and roofing materials fell from a two-story steel building (Photo 10); poor detailing of connection between the finishing and structural members (Photo 11).

Photo 9: Exterior finishing fell from a two-story steel building

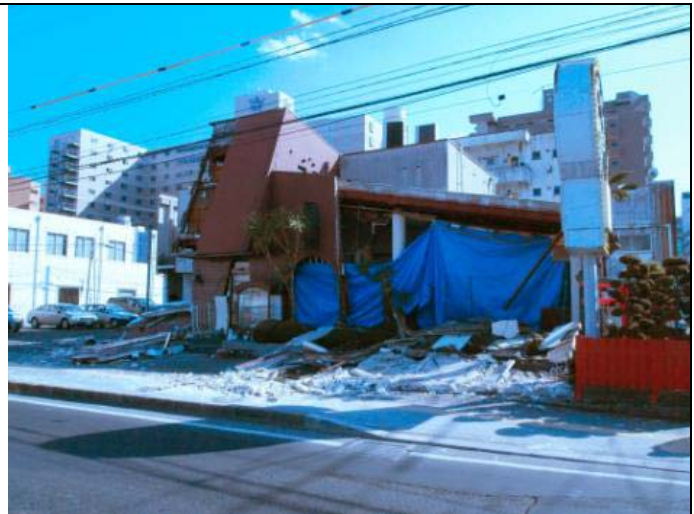
Photo 10: Fall of roofing materials from a two-story steel building

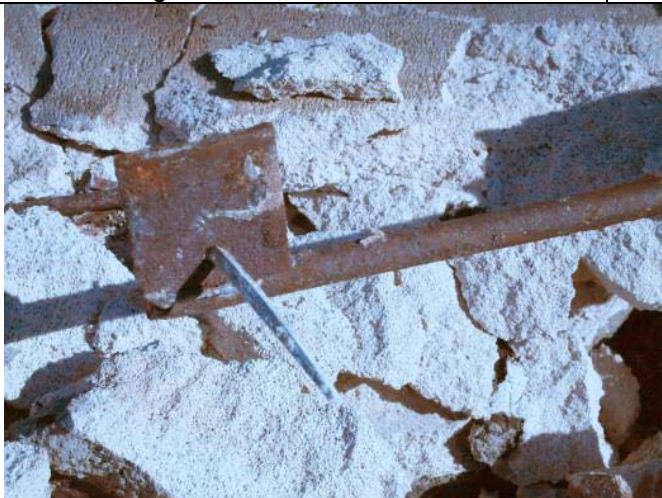
Photo 11: Detail of fastener (anchor) of fallen ALC exterior wall

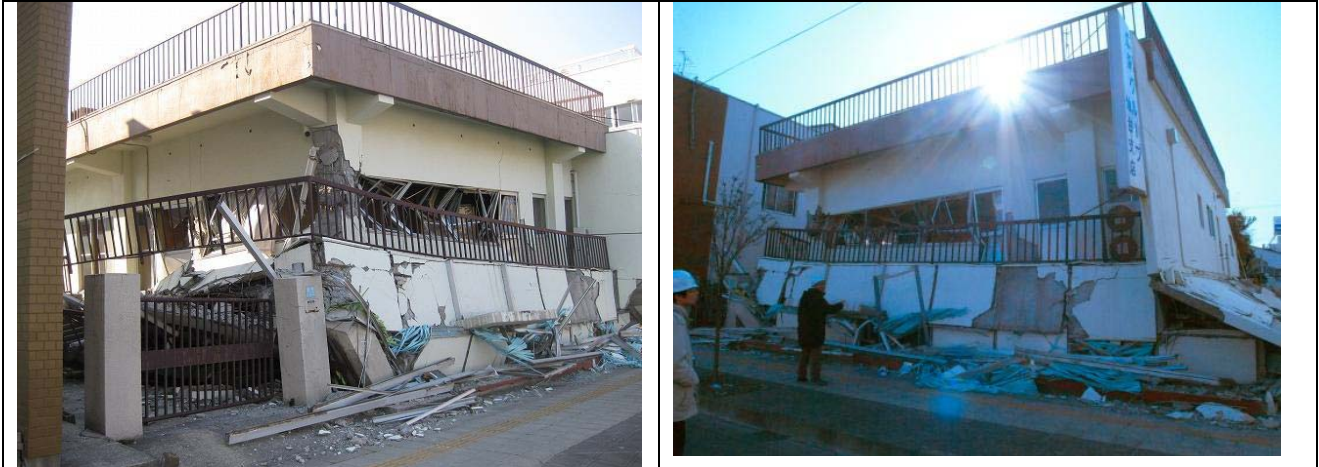
The first-story of a two-story reinforced concrete building collapsed in Oroshim-machi 2-chome (Photo

12); the first story is box wall construction, and the second-story is moment-resisting frame construction. The first story failed in the weak (out of plane) direction of the walls, and second-story columns failed in shear.

Photo 12: Collapse of a two-story reinforced concrete building in Oroshi-machi 2-chome, Wakabayashi-ku

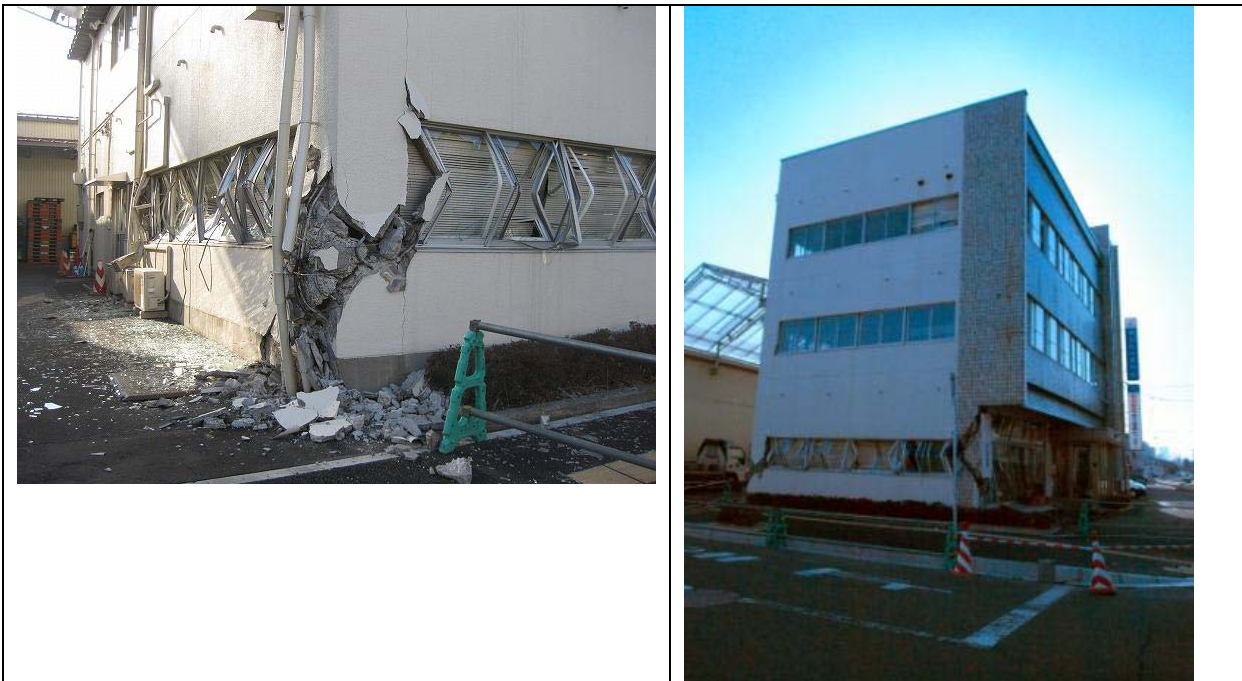
A part of the first story of a three-story reinforced concrete building collapsed in Oroshi-machi 3-chome (Photo 13); the diameter of plain longitudinal reinforcement was 19 mm, and tie reinforcement of diameter 9 mm at 250 mm on centers. The core of the building suffered slight damage, but the building was twisted by eccentricity and exterior columns failed in shear.

Photo 13: Collapse of a three-story reinforced concrete building in Oroshi-machi 3-chome, Wakabayashi-ku

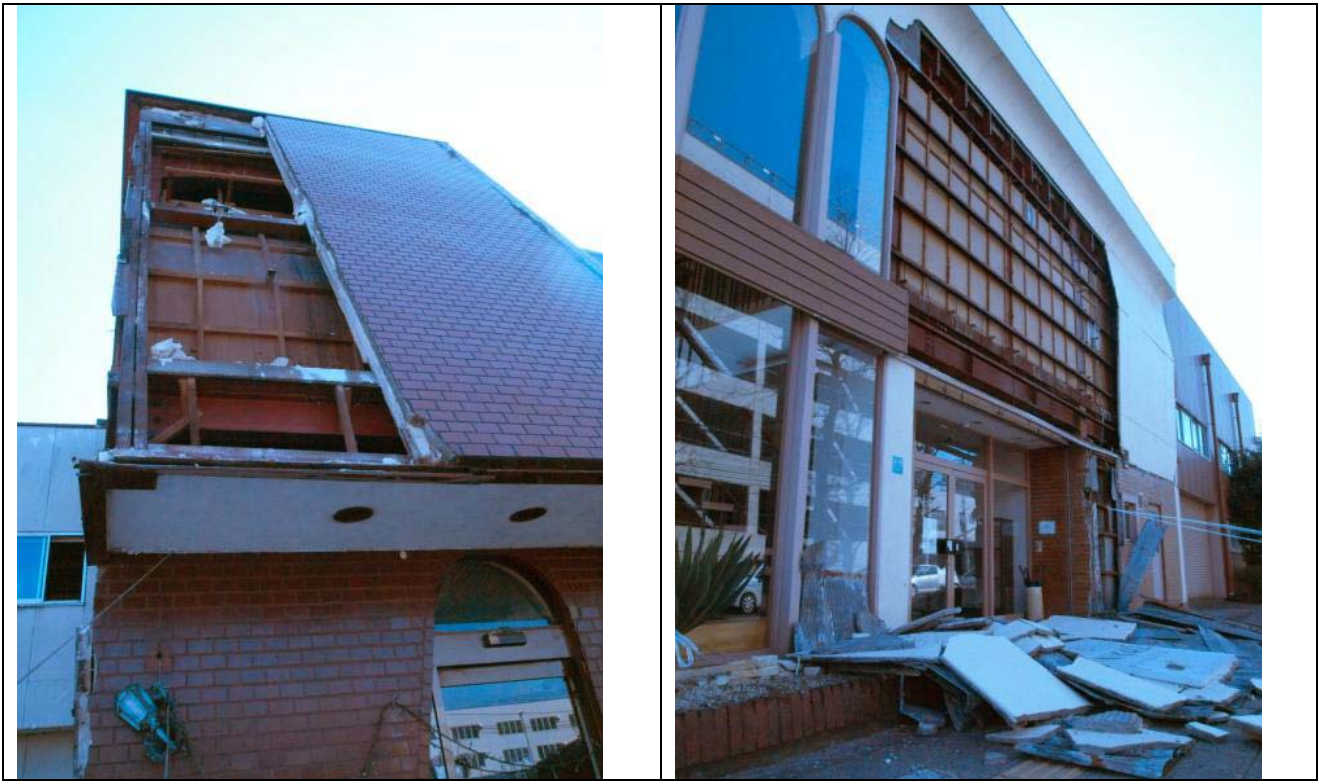
Many exterior curtain walls were observed to fall in Oroshi-machi (Photo 14). Concrete block fences were overturned in many locations (Photo 15).

Photo 14: Fall of exterior curtain walls in steel construction

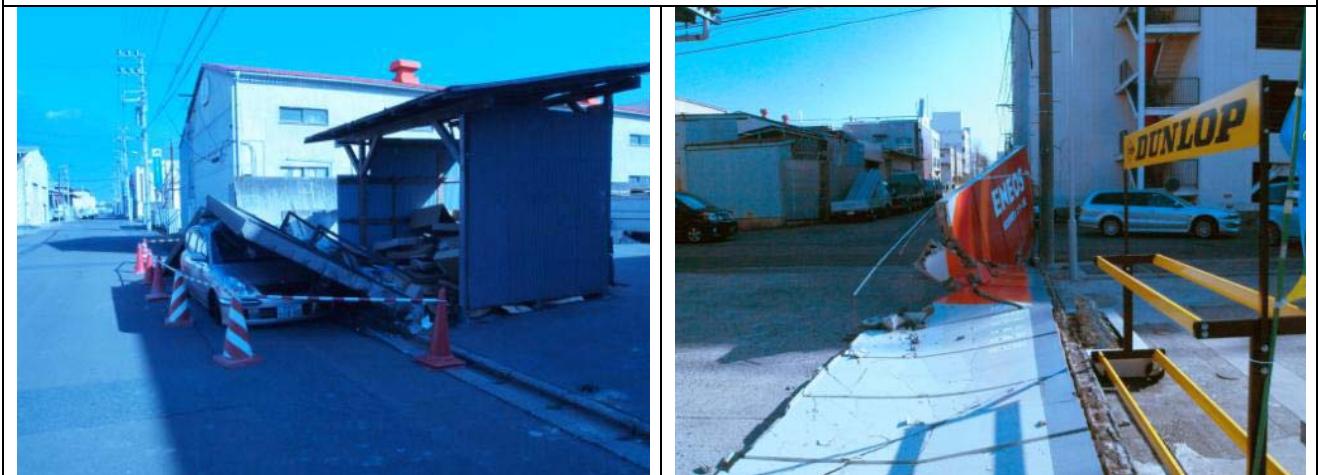
Photo 15: Overturned concrete block fences in Oroshi-machi, Wakabayashi-ku

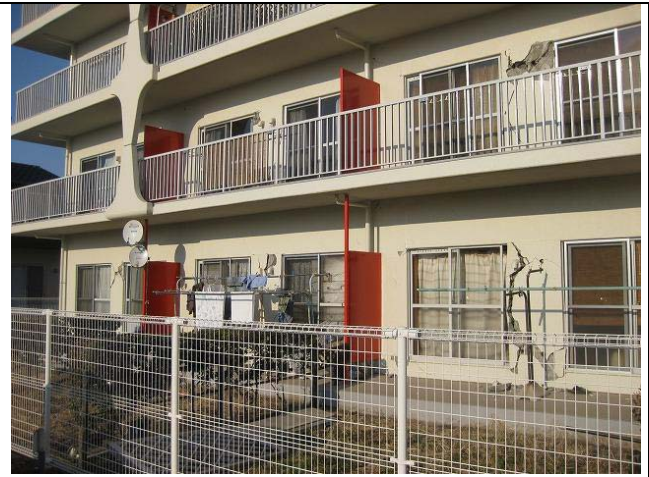
damage in the upper stories appeared light; non-structural exterior walls showed shear cracking in the longitudinal direction; the tilting rotation was observed in the short direction and the residual lateral displacement at the 14-th floor was estimated to be 400 mm by visual observation. The first floor indicating inclination; the pile might be damaged. The investigation team told the occupants that further detailed investigation might be necessary. The occupants by their own method monitored the separation of the expansion joints, and the tilting is reported to increase (March 15). The damage in piles is suspected.

Photo 17: Shear failure of non-structural exterior walls

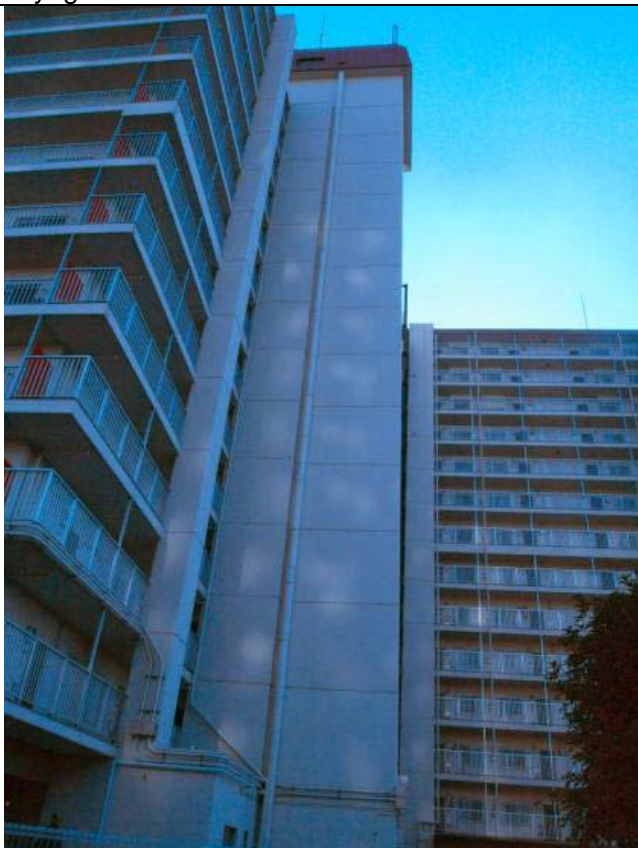
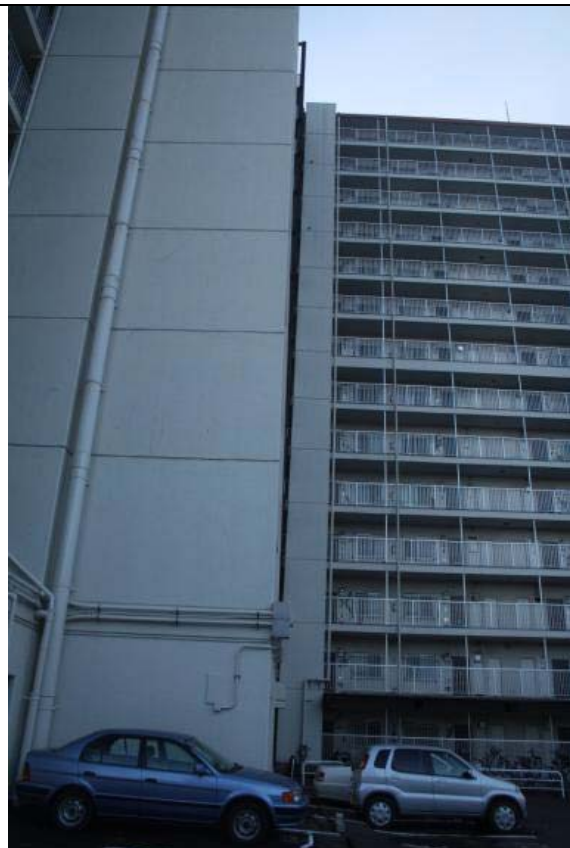
Photo 18: Expansion joint between two buildings (left on March 12, and right on March 16)

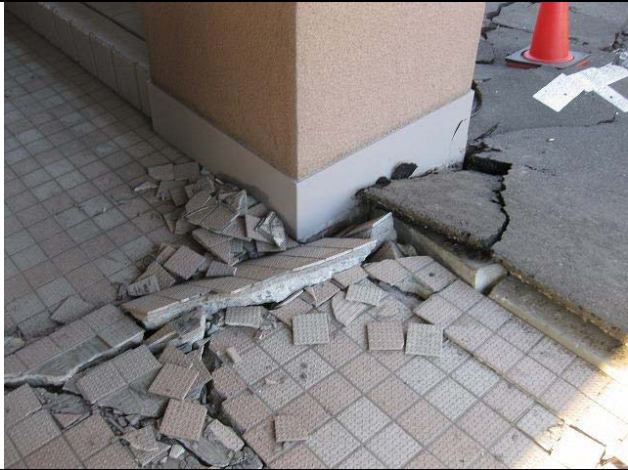
Photo 19: Damage at the base of a first-story column

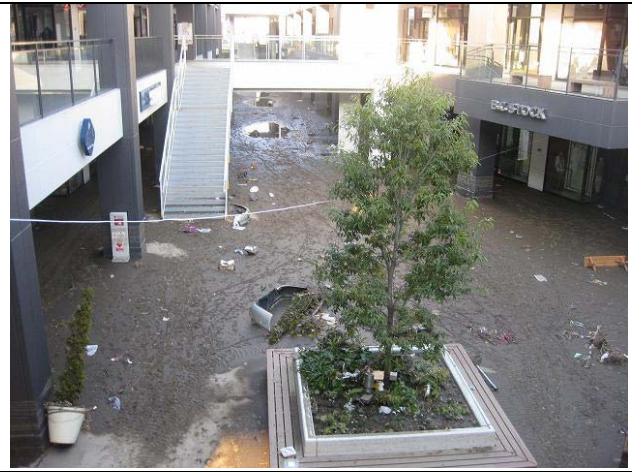
Tsunami water reached 1.0 m high in a large shopping mall, Mitsui Outlet. Some cars were floated and moved in the parking area by the tsunami wave. However, water did not go into shops. No vibration damage is observed in the buildings (Photos 20 and 21).

Photo 21: Damage of the Mitsui Outlet Mall building by the tsunami (Second floor deck)

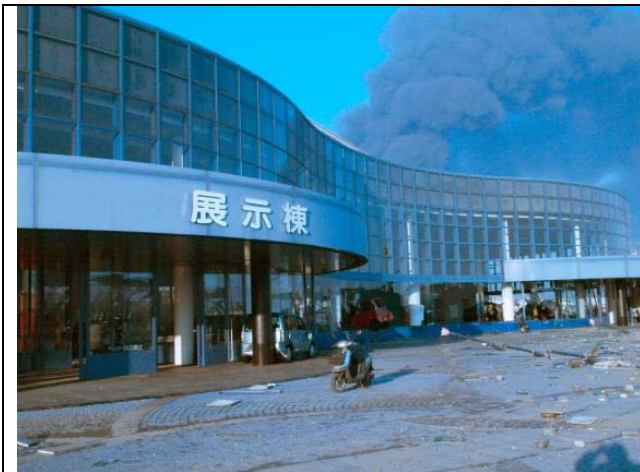
Some cars were floated and moved into the exhibition hall of Miyagi Yume Messe, and broke exterior glasses (Photos 22 and 23). No damage of the building was observed caused by the vibration of the earthquake.

Photo 22: Damage of Miyagi Yume Messe by tsunami

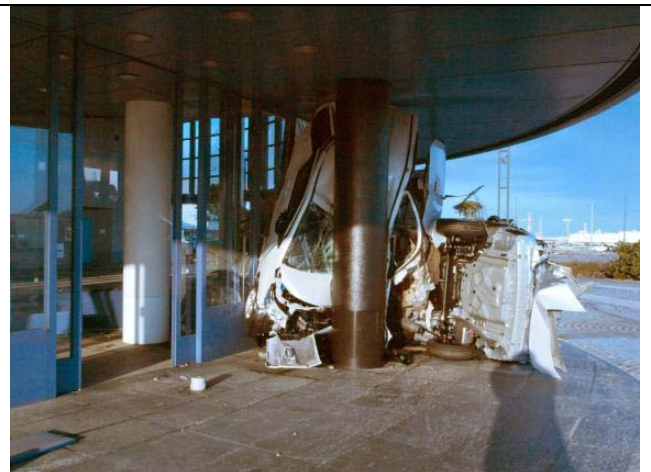
Photo 23: Cars were carried into the exhibition building by tsunami wave

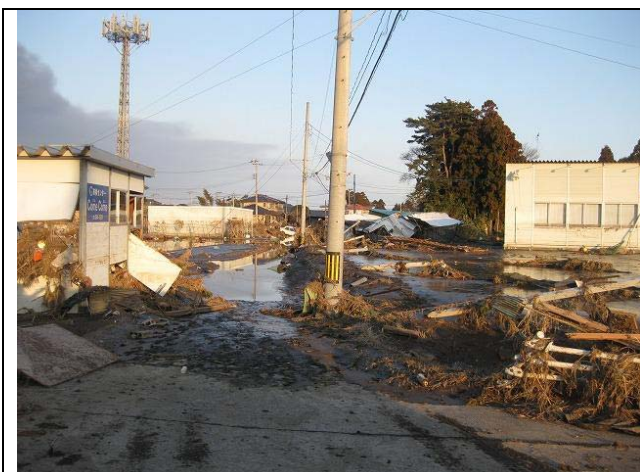
It was not possible to visit residential areas of Gamoh area due to heavy damage by tsunami (Photo 24).

Photo 24: Damage of Gamoh residential area due to tsunamis

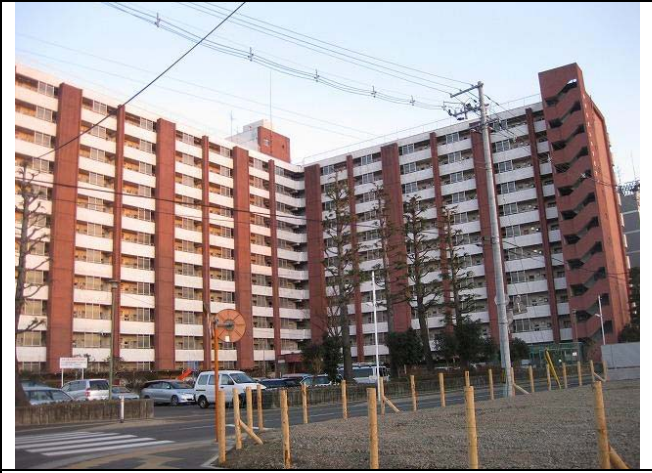
A 11-story reinforced concrete condominium building, which tilted attributable to the damage in piles after the 1978 Miyagi-ken Oki Earthquake, suffered no damage. The 11-story reinforced concrete building normal to the longitudinal building showed the trace of rocking motion, and cracking was observed in the ground along the base, no residual displacement was observed at the expansion joint; no inclination of the building was detected (Photo 25). The damage in piles appeared slight if any.

Photo 25: Kohriyama Municipal Apartment Building
in Nagamachi, Taihaku-ku

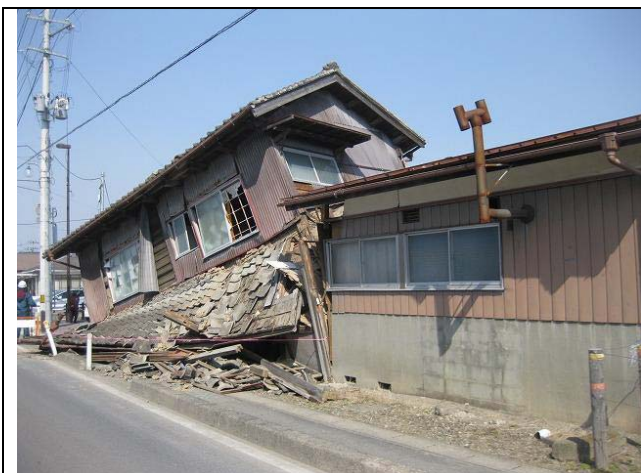
First-story collapse of residential buildings were seen here and there; the damage is serious. Even in those buildings without collapse, serious damage was observed such as fall of external walls.

Photo 2: Collapse of a two-story timber house

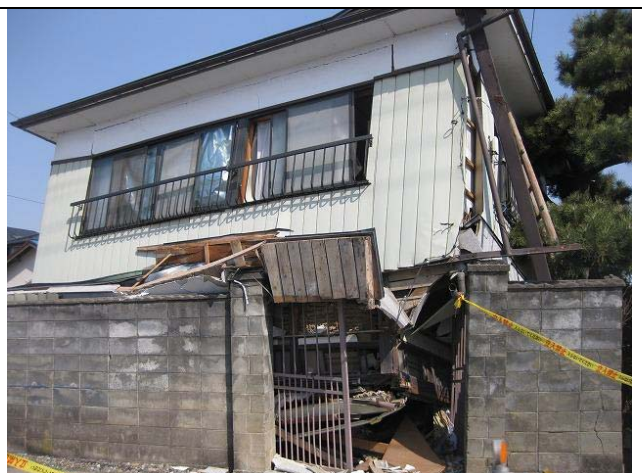
Photo 3: Collapse of a two-story timber house

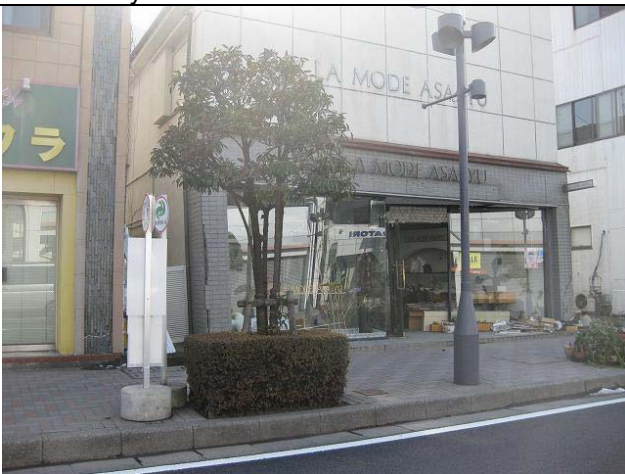
Photo 8: A tilted two-story house for combined use for shop and residence

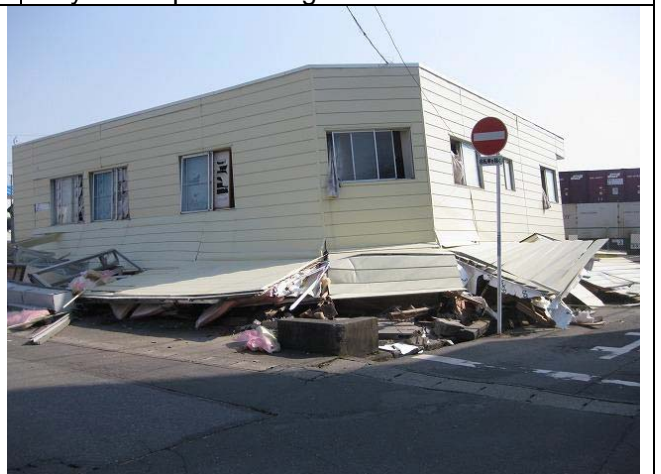
Photo 9: Collapse of a two-story house for combined use for shop and residence

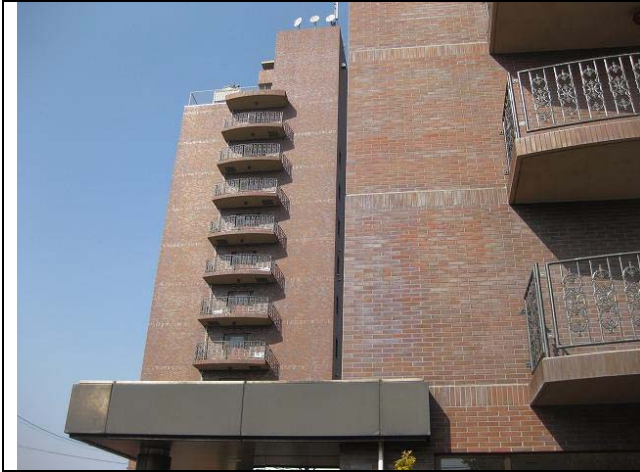
There is a 11-story reinforced concrete hotel in front of Furukawa Station. No structural damage in the super structure is observed, but the tilting of the building is observed probably due to ground movement (Photos 10 and 11).

Photo 10: Tilting of a 11-story reinforced concrete hotel building

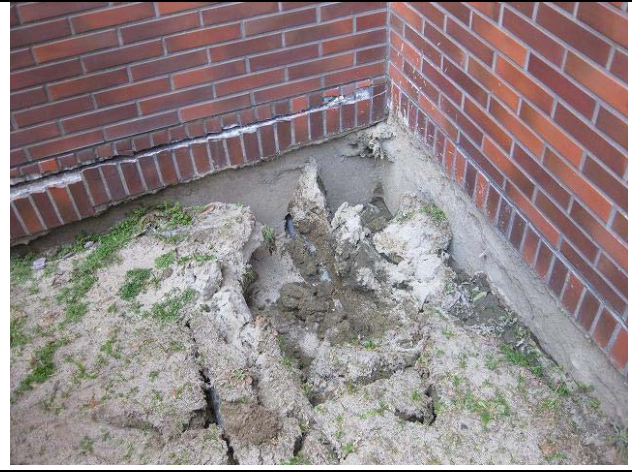
Photo 11: Boundary of foundation and ground at the base of the 11-story reinforced concrete hotel building

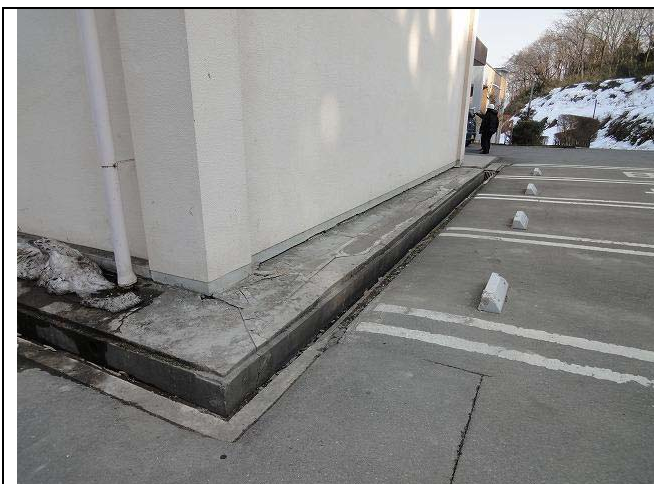
Damage of roof tiles was observed in a very limited number of houses, but not serious damage, In the Iwadeyama High School, ground fissure was observed along the scarcement of f the building (Photo 12), but no serious structural damage was detected.

Photo 12: Ground cracking along the periphery of the building

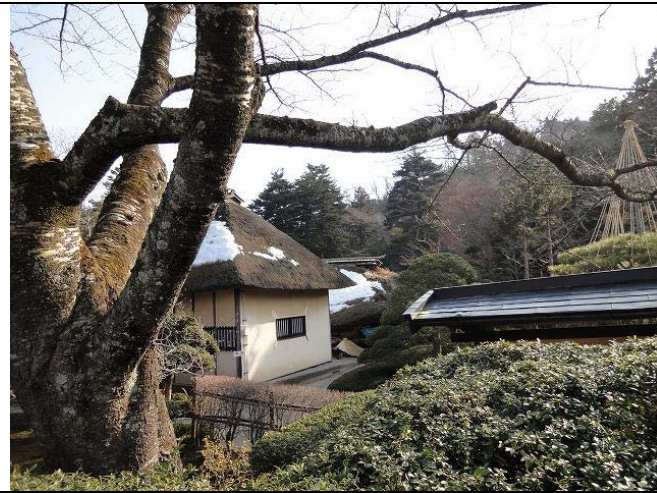
The Yuhbi-kan, a traditional farm house with thatch roof, collapsed completely in Iwade-district of Ohsaki City.

Photo 13: Collapse of the Yuhbi-kan in the back of the picture

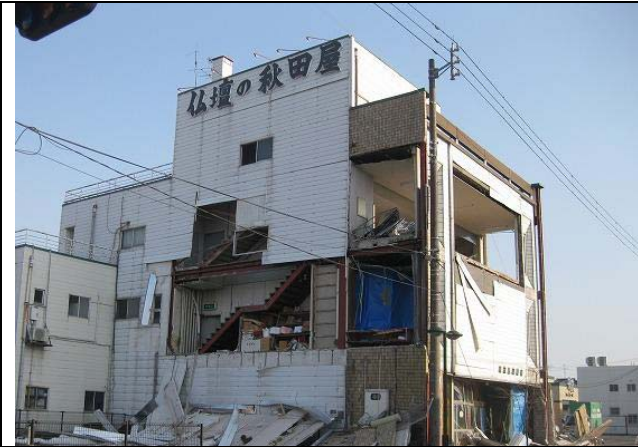
No structural damage was observed from Kaminome Elementary School to National Route 457. In the urban area of Kami-machi Nakaniida District, many external non-structural walls fell from a three-story steel commercial building.

Photo 15: Fall of external non-structural walls from a three-story steel commercial building
