The 2011 Off the Pacific Coast of Tohoku Earthquake
- Quick Investigation Report on Earthquake Damage on Buildings -

Professor Masato Motosaka, Tohoku University
(Translation by Shunsuke Otani, University of Tokyo)

March 12, Saturday, Preliminary Investigation

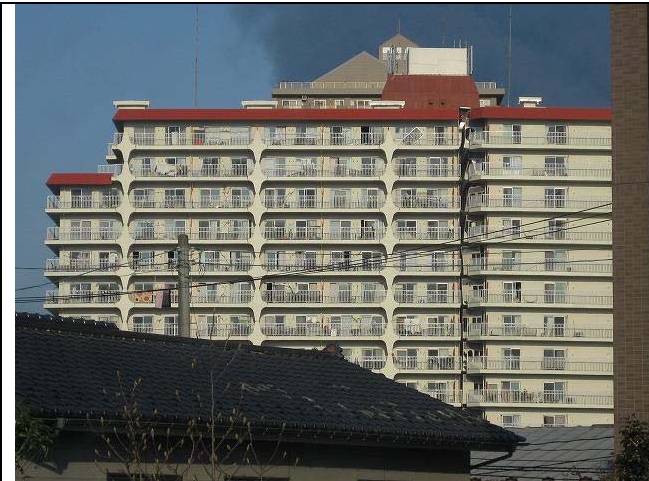
This high-rise condominium buildings suffered damage in pile foundation during the 1978 Miyagi-ken Oki Earthquake. There are two buildings. A building located normal to Route 45, suffered slight structural damage although non-structural partitions failed in shear; no tilting was observed in this building. A building facing to Route 45 showed tilting in the short direction (confirmed on March 12) although the

damage in the upper stories appeared light; non-structural exterior walls showed shear cracking in the longitudinal direction; the tilting rotation was observed in the short direction and the residual lateral displacement at the 14-th floor was estimated to be 400 mm by visual observation. The first floor indicating inclination; the pile might be damaged. The investigation team told the occupants that further detailed investigation might be necessary. The occupants by their own method monitored the separation of the expansion joints, and the tilting is reported to increase (March 15). The damage in piles is suspected.

Photo 16: Condominium buildings in Takasago, Miyagino-ku

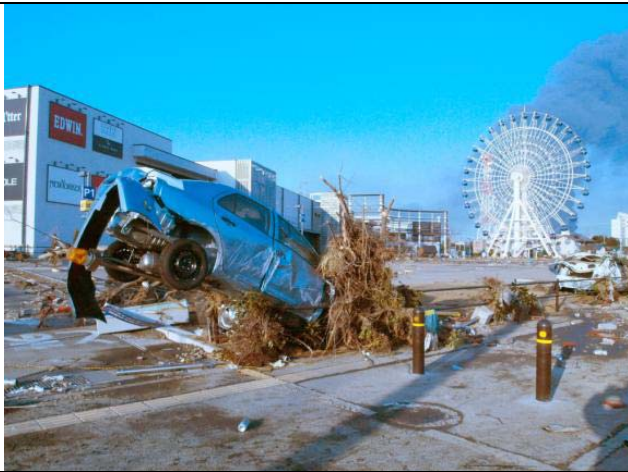
Tsunami water reached 1.0 m high in a large shopping mall, Mitsui Outlet. Some cars were floated and moved in the parking area by the tsunami wave. However, water did not go into shops. No vibration damage is observed in the buildings (Photos 20 and 21).

Photo 20: The parking area of the Mitsui Outlet shopping mall

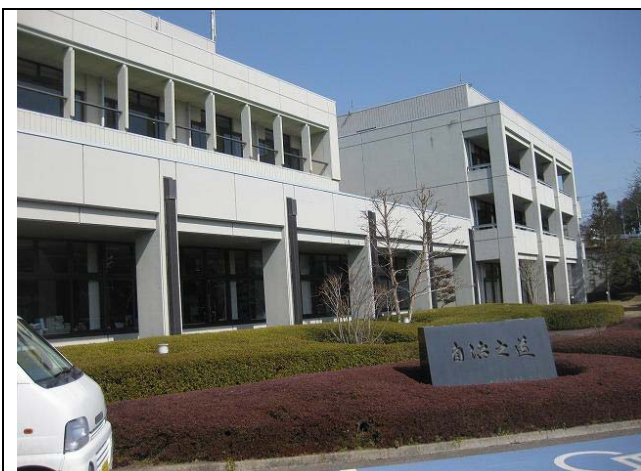
Seismic intensity (Japan Meteorological Agency Scale, JMA scale) of higher 6 was measured by the municipal intensity instrument. The municipal office is in a two-story reinforced concrete building (Photo 1); no major cracks were observed. No serious damage has been reported in the village.

Photo 1: External view of the Ohhira Village Municipal Office Building

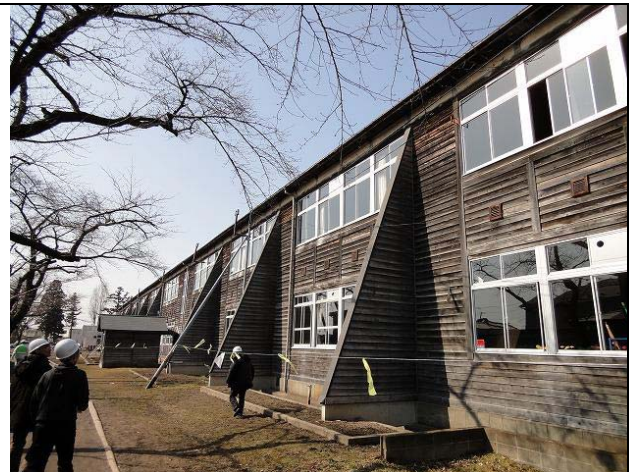
There are old houses used for combination of shop and residence, and godowns (storehouse made of mud walls) in Furukawa Mikka-machi and Nanoka-machi near the Ohsaki City Municipal Building. Many of these houses collapsed. The Furukawa No.1 Elementary School of two-story timber construction was prohibited to enter due to possible collapse during aftershocks. A seismic intensity instrument at Mikka-machi recoded the ground shaking of intensity higher 6 (JMA intensity scale).

Photo 5: Ohsaki City Municipal Furukawa No.1 Elementary School (two-story timber construction)

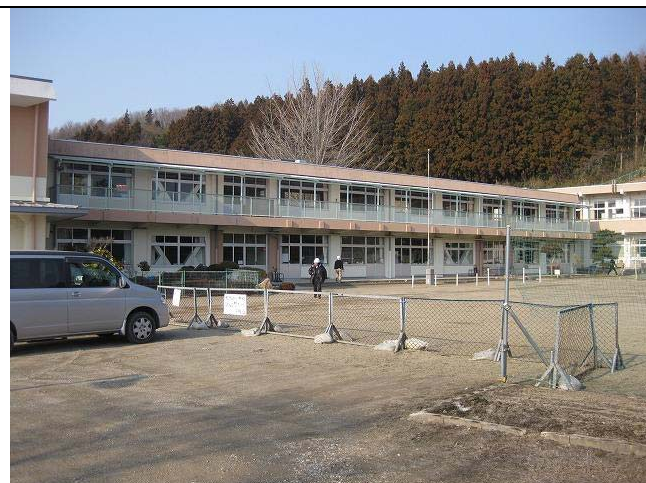
The Kaminome Elementary School building suffered serious damage in the 2008 Iwate- Miyagi Inland Earthquake. The damage was repaired and steel braces were used for retrofit. No damage was observed in this earthquake.

Photo 14: Overview of Uenome Elementary School (No damage)
